Bear Brook and Ramsay Creek Watersheds Fluvial Geomorphological Study

Existing Conditions Summary Report Tewin Lands

December 12, 2024

GEO Morphix Project No. 21063

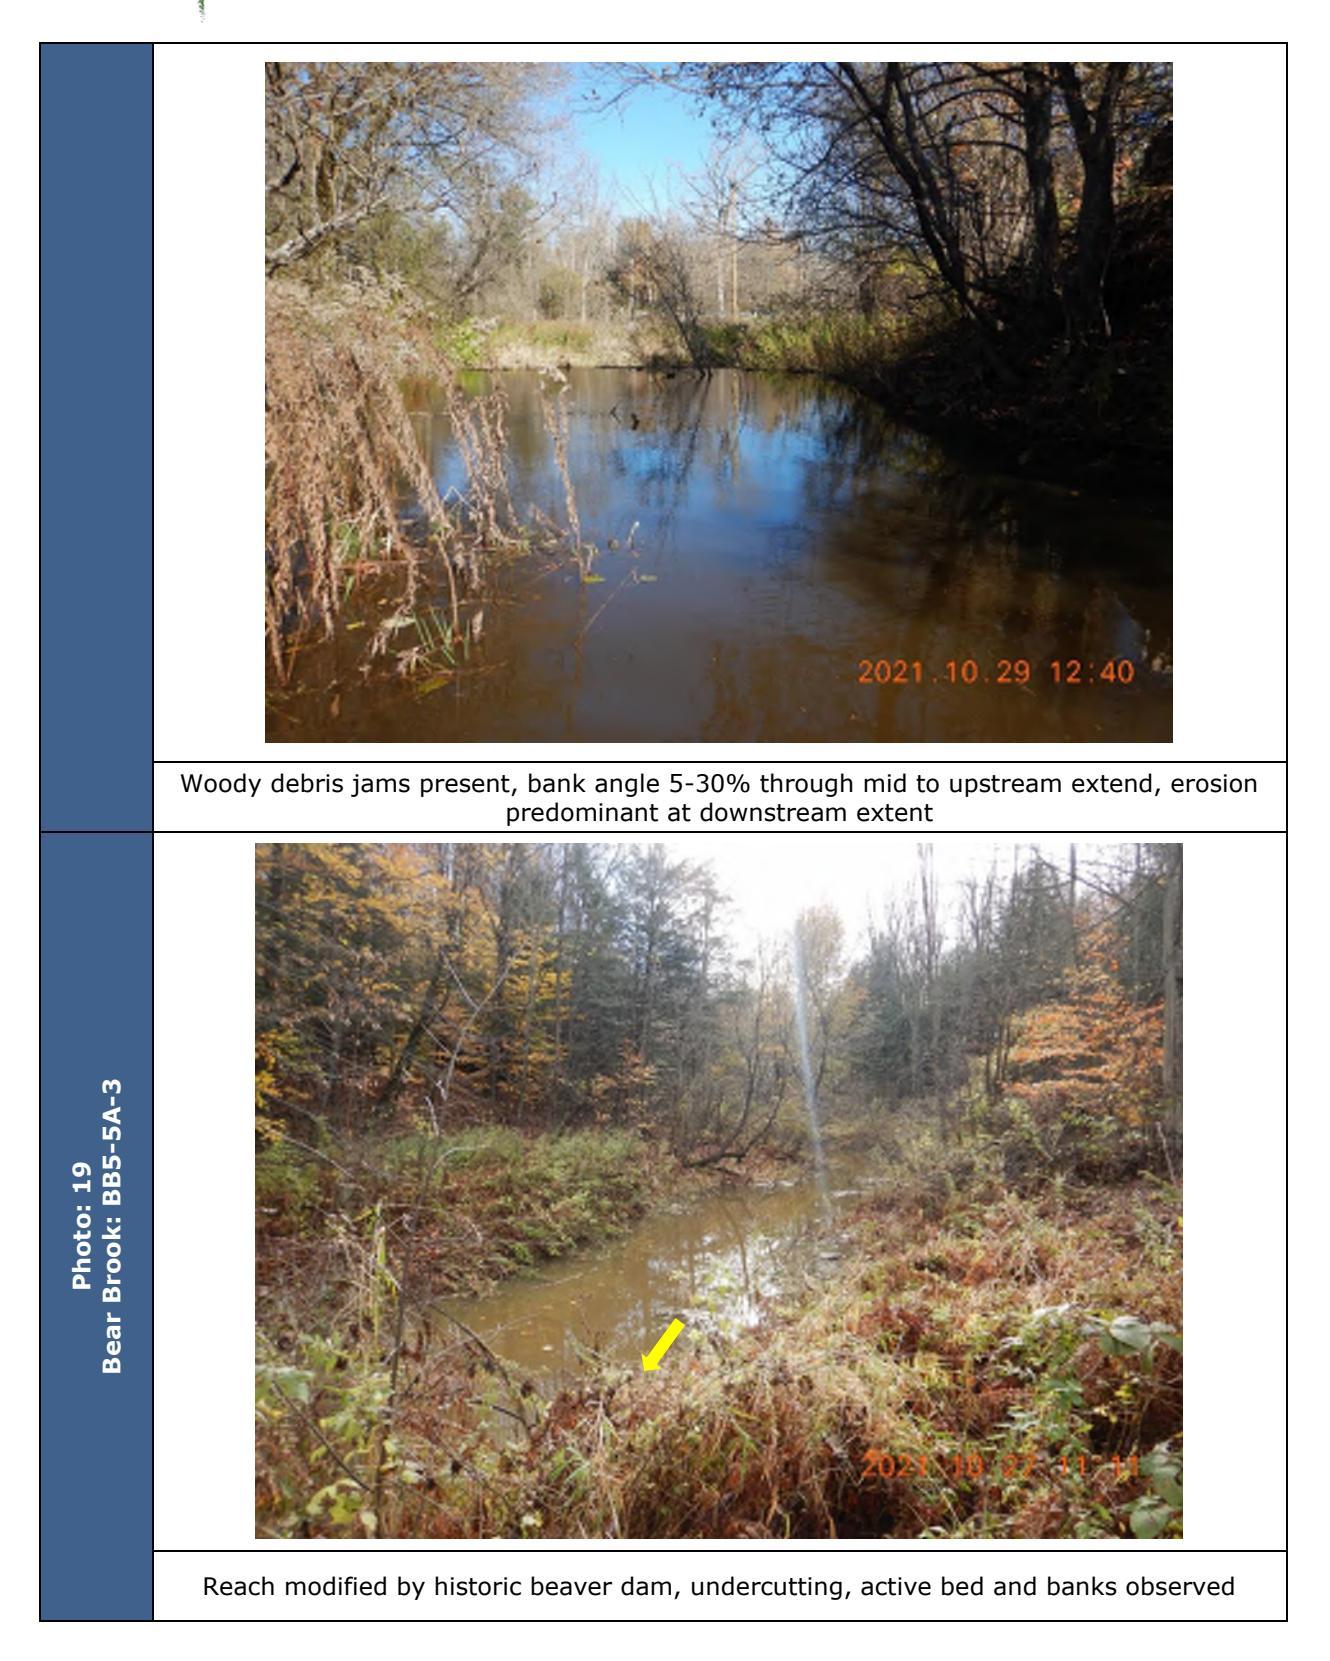
Feature characteristic of a large pond due to back watering from a beaver dam.

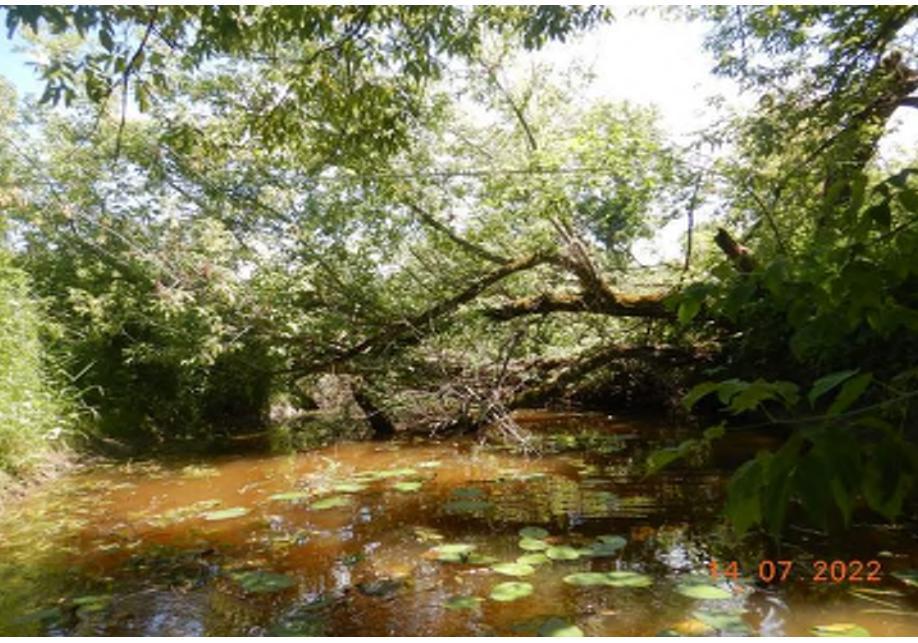
Cross Section 4 - Facing Downstream

Reach BB1 is a low gradient channel that passes through an unconfined valley. Riparian vegetation was characterized by grasses and some mature trees. Rooted submergent and emmergent vegetation was common along the reach, however vegetation encroachment was minimal. Substrate consisted of clay to sand in both the pools and the riffles. Average bankfull width and depth were 9.63 m and 1.22 m, respectivly. Some undercutting was observed, up to 0.35 m and bank slumping was present.

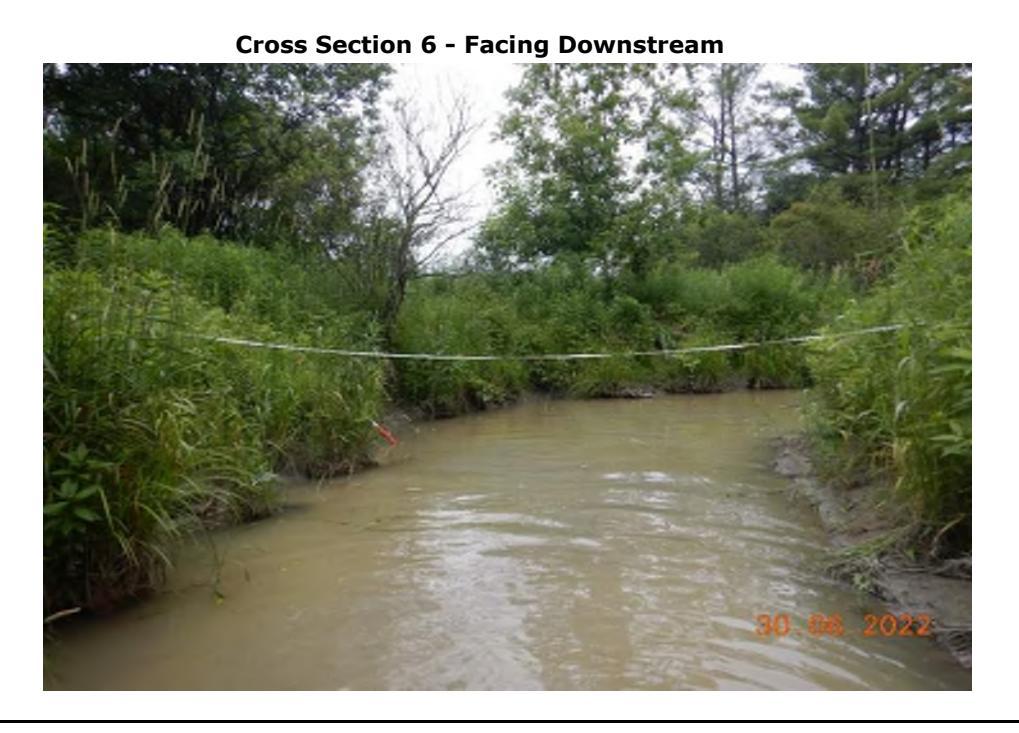
Reach RC1 was a low gradient meandering channel that flowed through an unconfined valley. Riparian vegetation was predominantly characterized by grasses and small shrubs. There was minor encroachment of emergent-type vegetation into the channel. Channel substrates consisted mainly of clays and sands. Although, some gravel and cobbles were found in riffles. Average bankfull width and depth were 6.30 m and 0.79 m, repsectively. Bank undercutting was observed up to a maximum of 0.30 m. In addition, bank slumping was common throughout the reach.

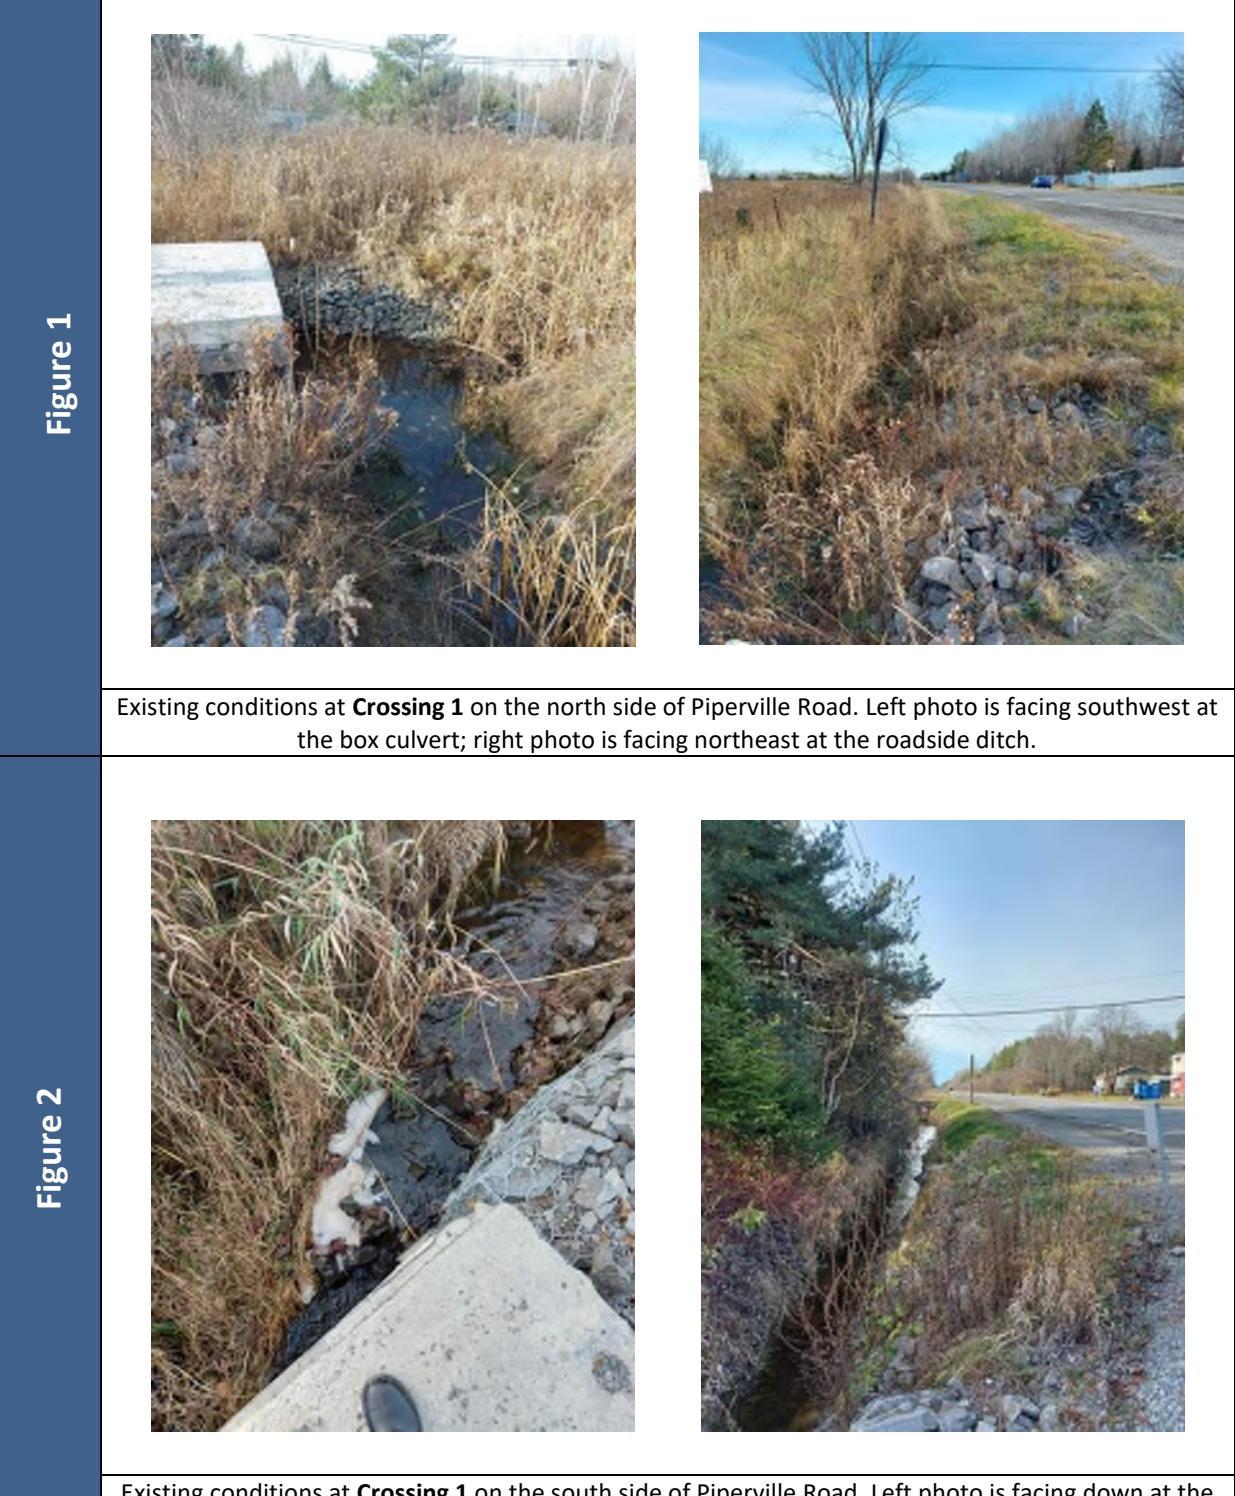
Existing conditions at **Crossing 1** on the south side of Piperville Road. Left photo is facing down at the box culvert opening; right photo is facing southwest at the roadside ditch.

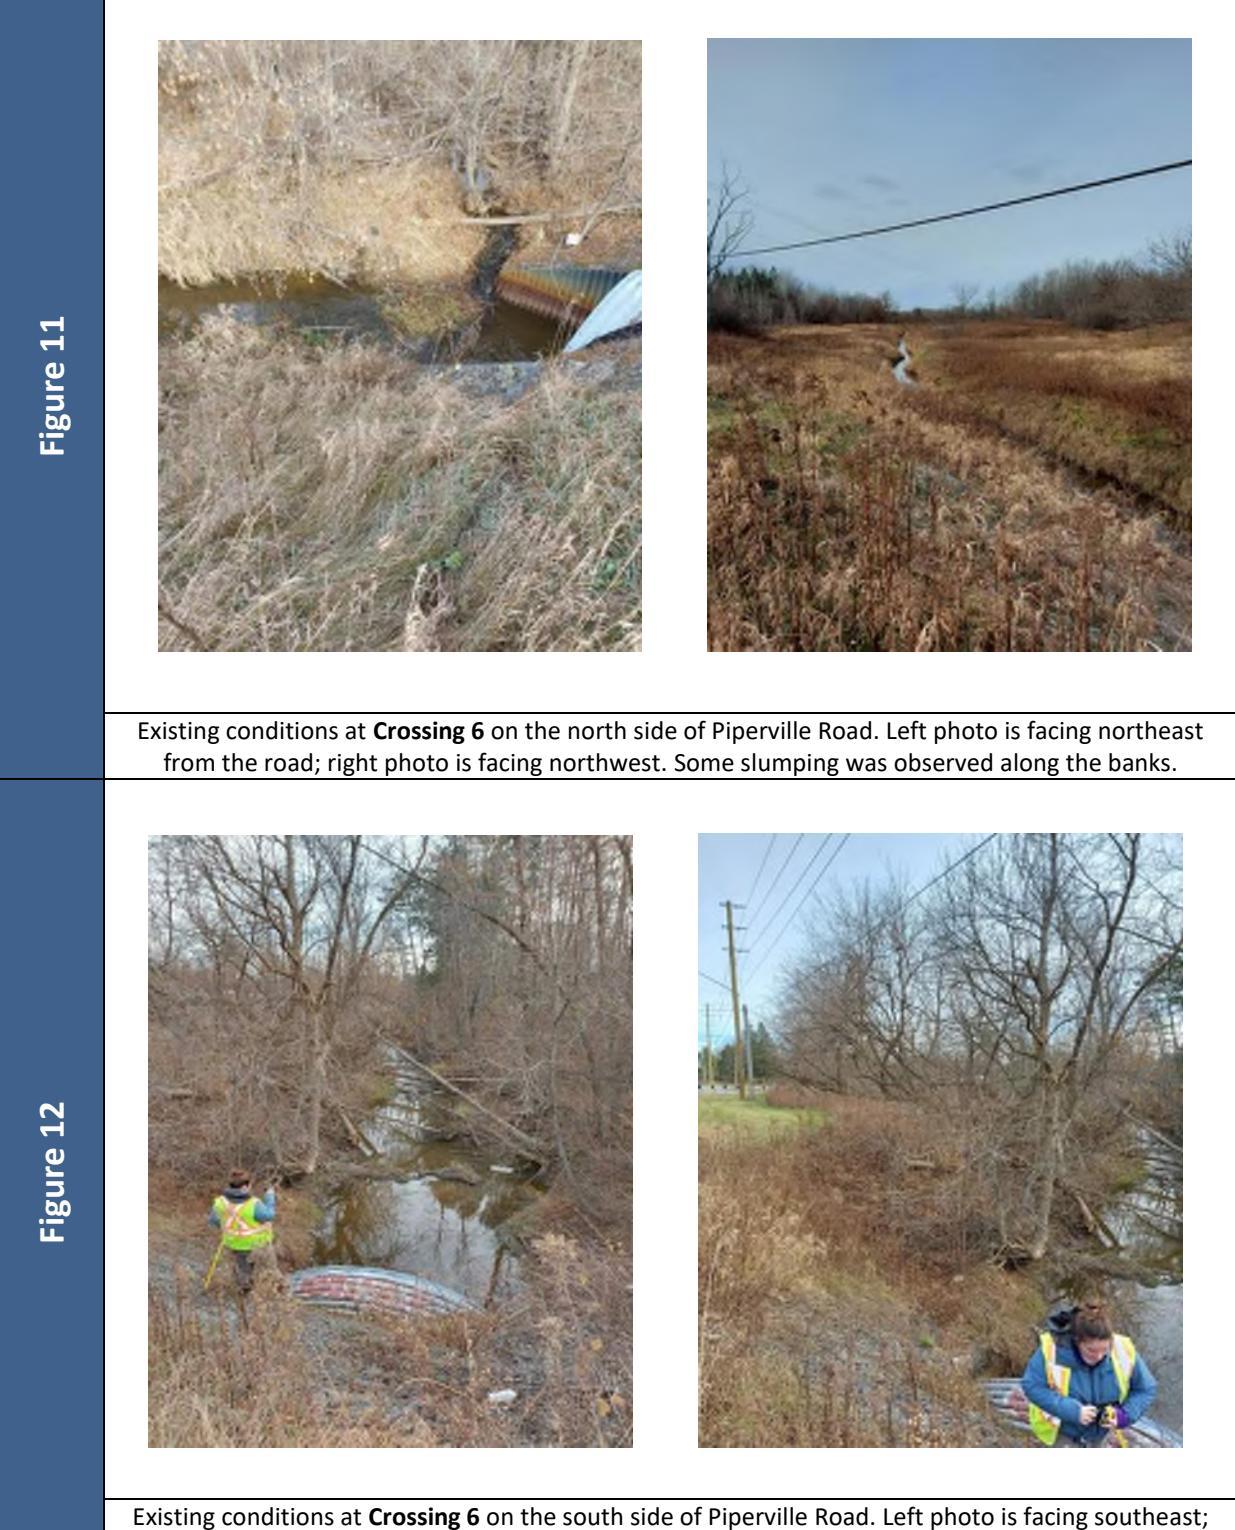
Existing conditions at **Crossing 6** on the south side of Piperville Road. Left photo is facing southeast; right photo is facing east along Piperville Road. Some erosion scars and fallen trees were observed.

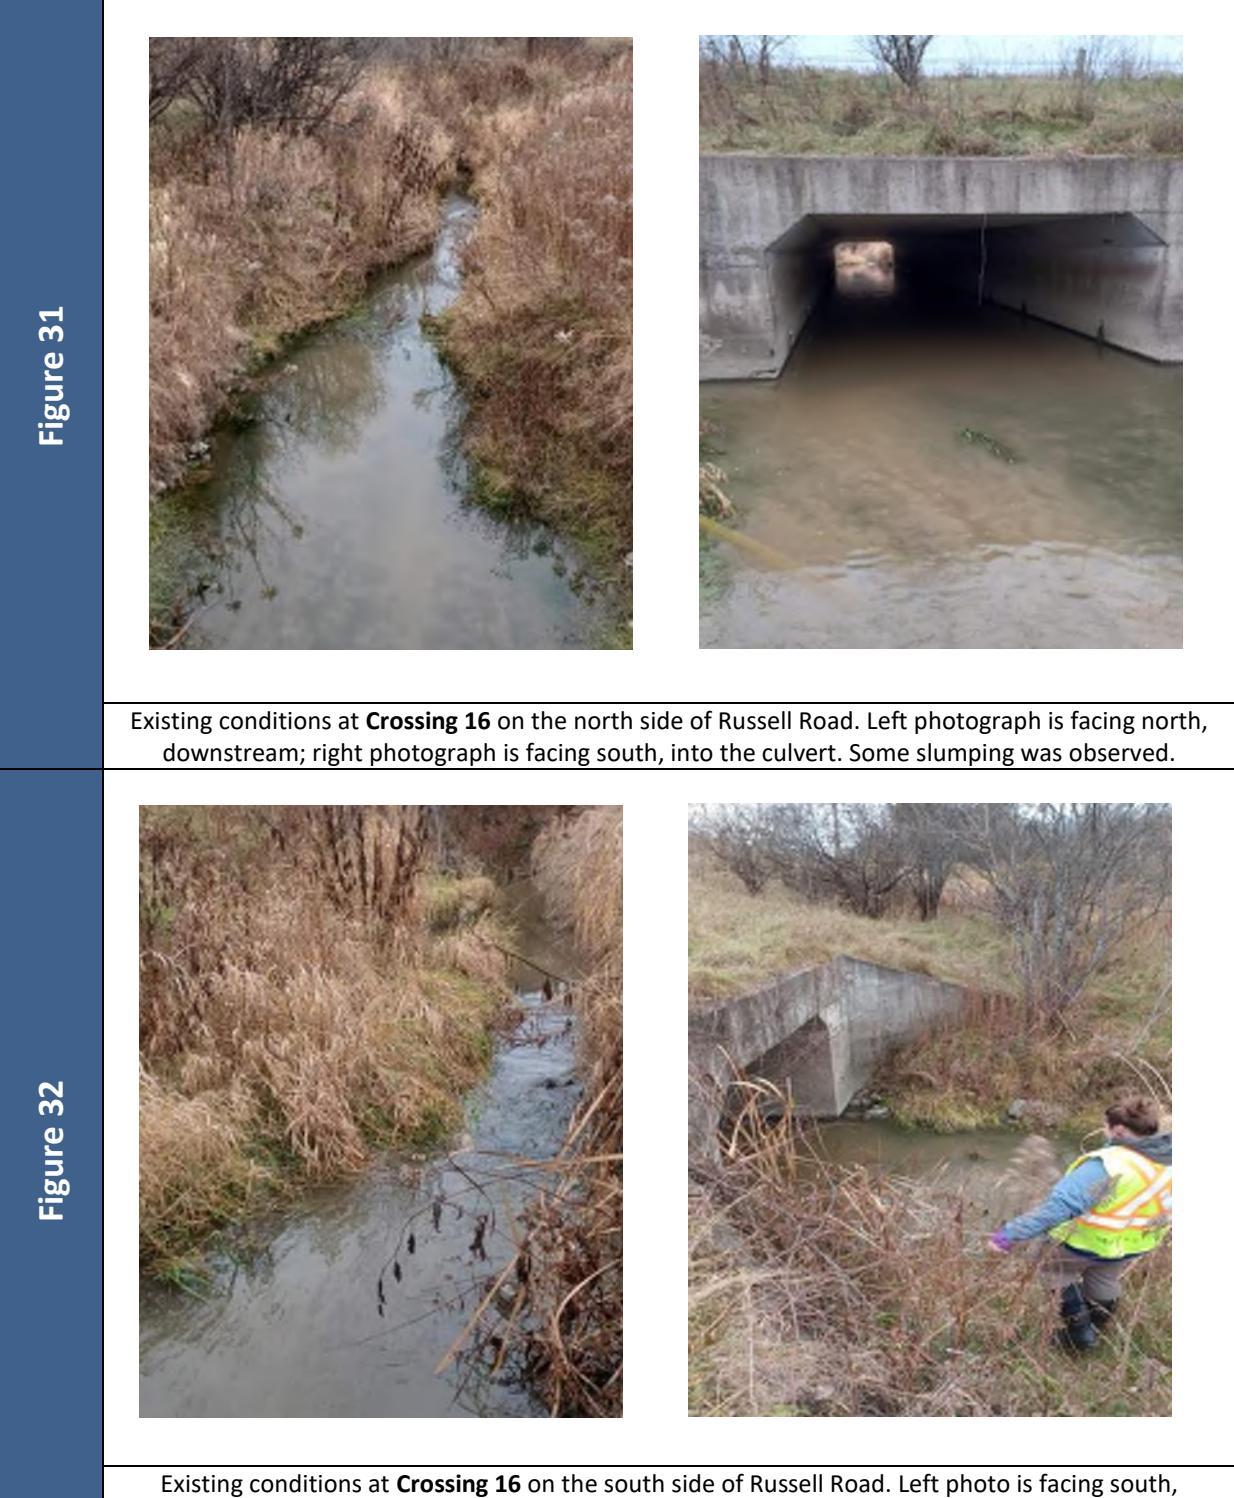
A conditions at Crossing 16 on the south side of Russell Road. Left photo is facing sout upstream; right photo is facing southeast. Some slumping was observed..

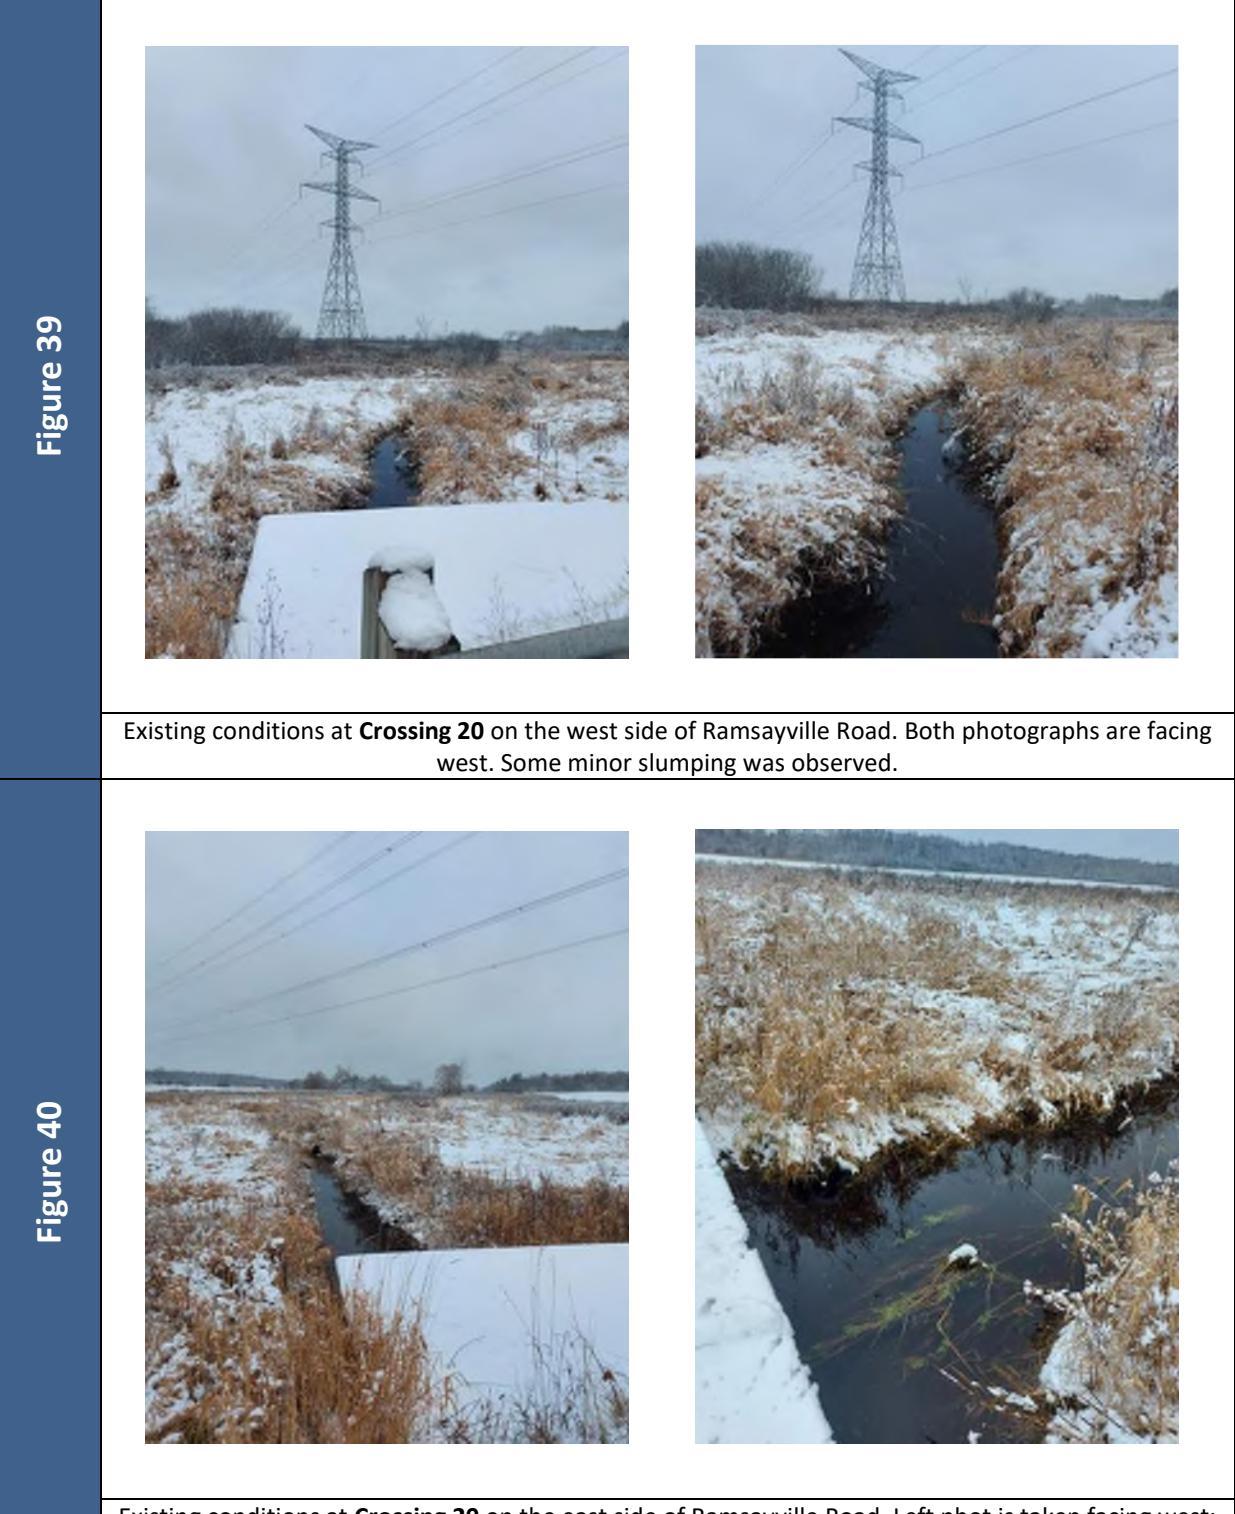
Existing conditions at **Crossing 20** on the east side of Ramsayville Road. Left phot is taken facing west; right photo is taken facing northeast. Some slumping was observed.

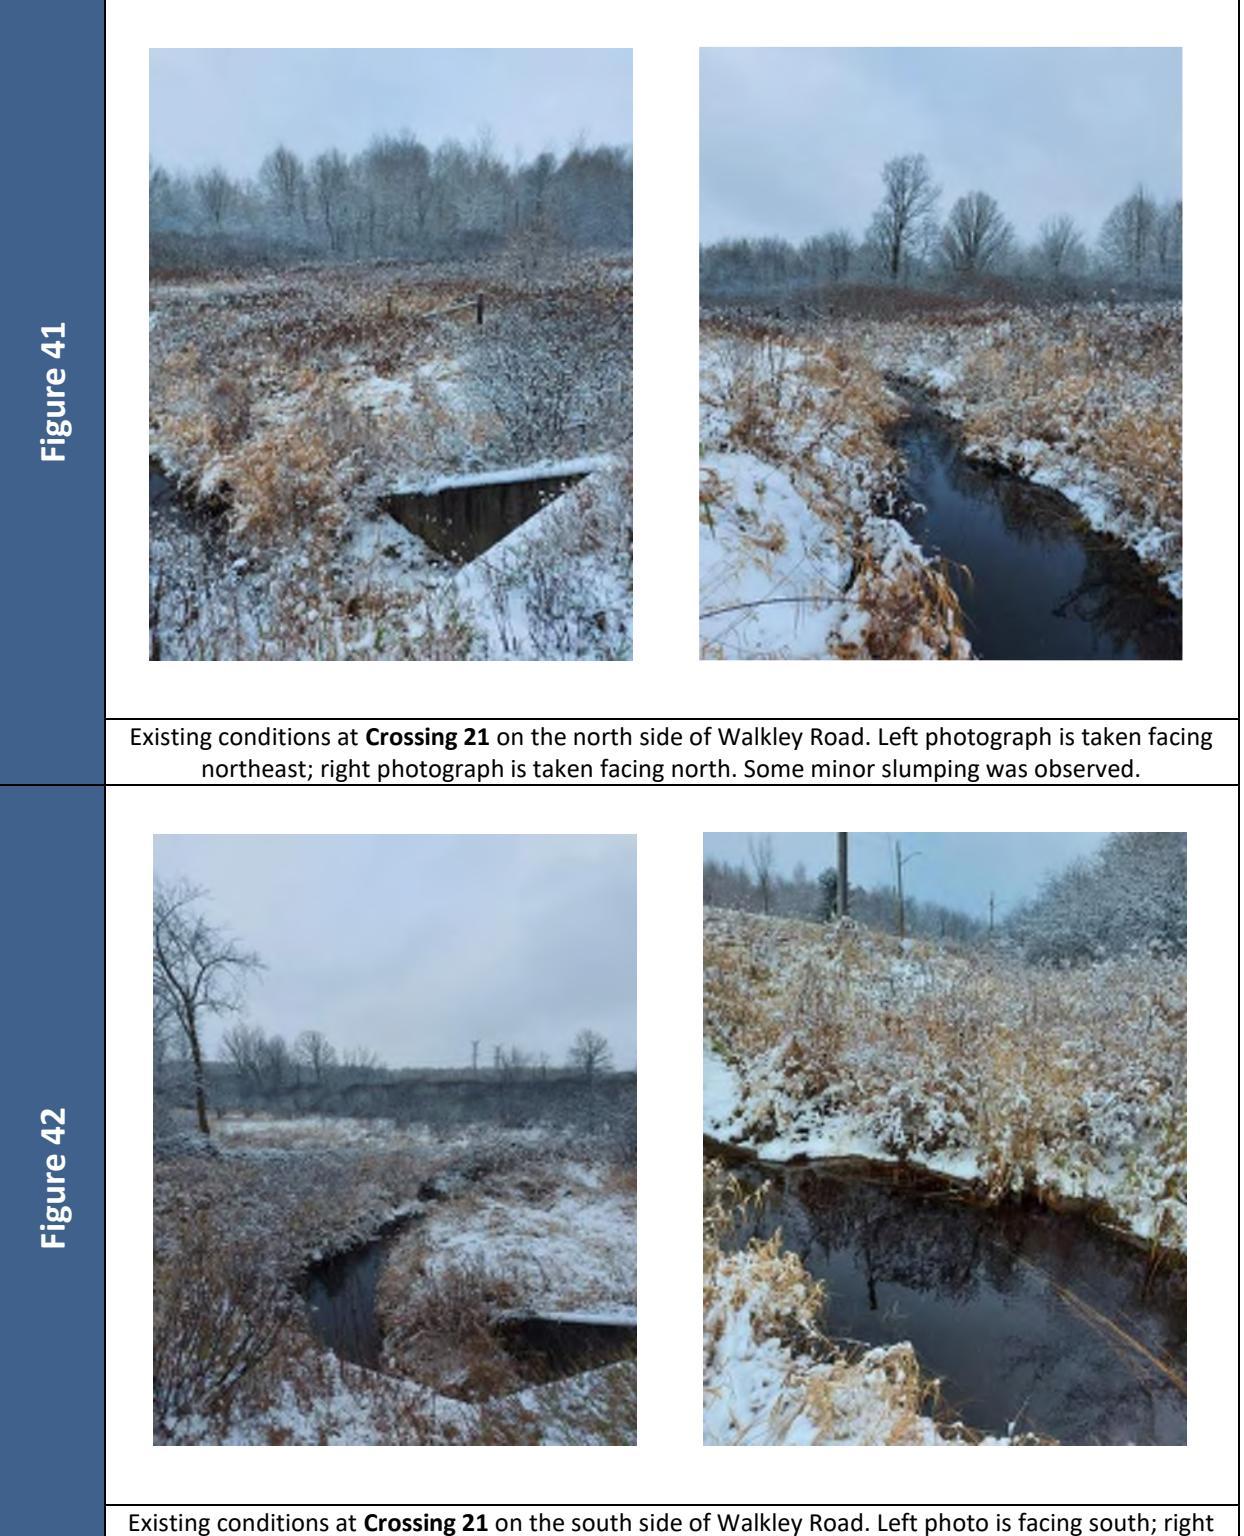
photo is facing east. Some minor slumping was observed.
