**Re: Background Review and Drainage Characterization of Ramsay Creek
Tewin Secondary Plan Area
City of Ottawa, Ontario
GEO Morphix Project No. 21063**

**Ramsay Creek
Reach Delineation**

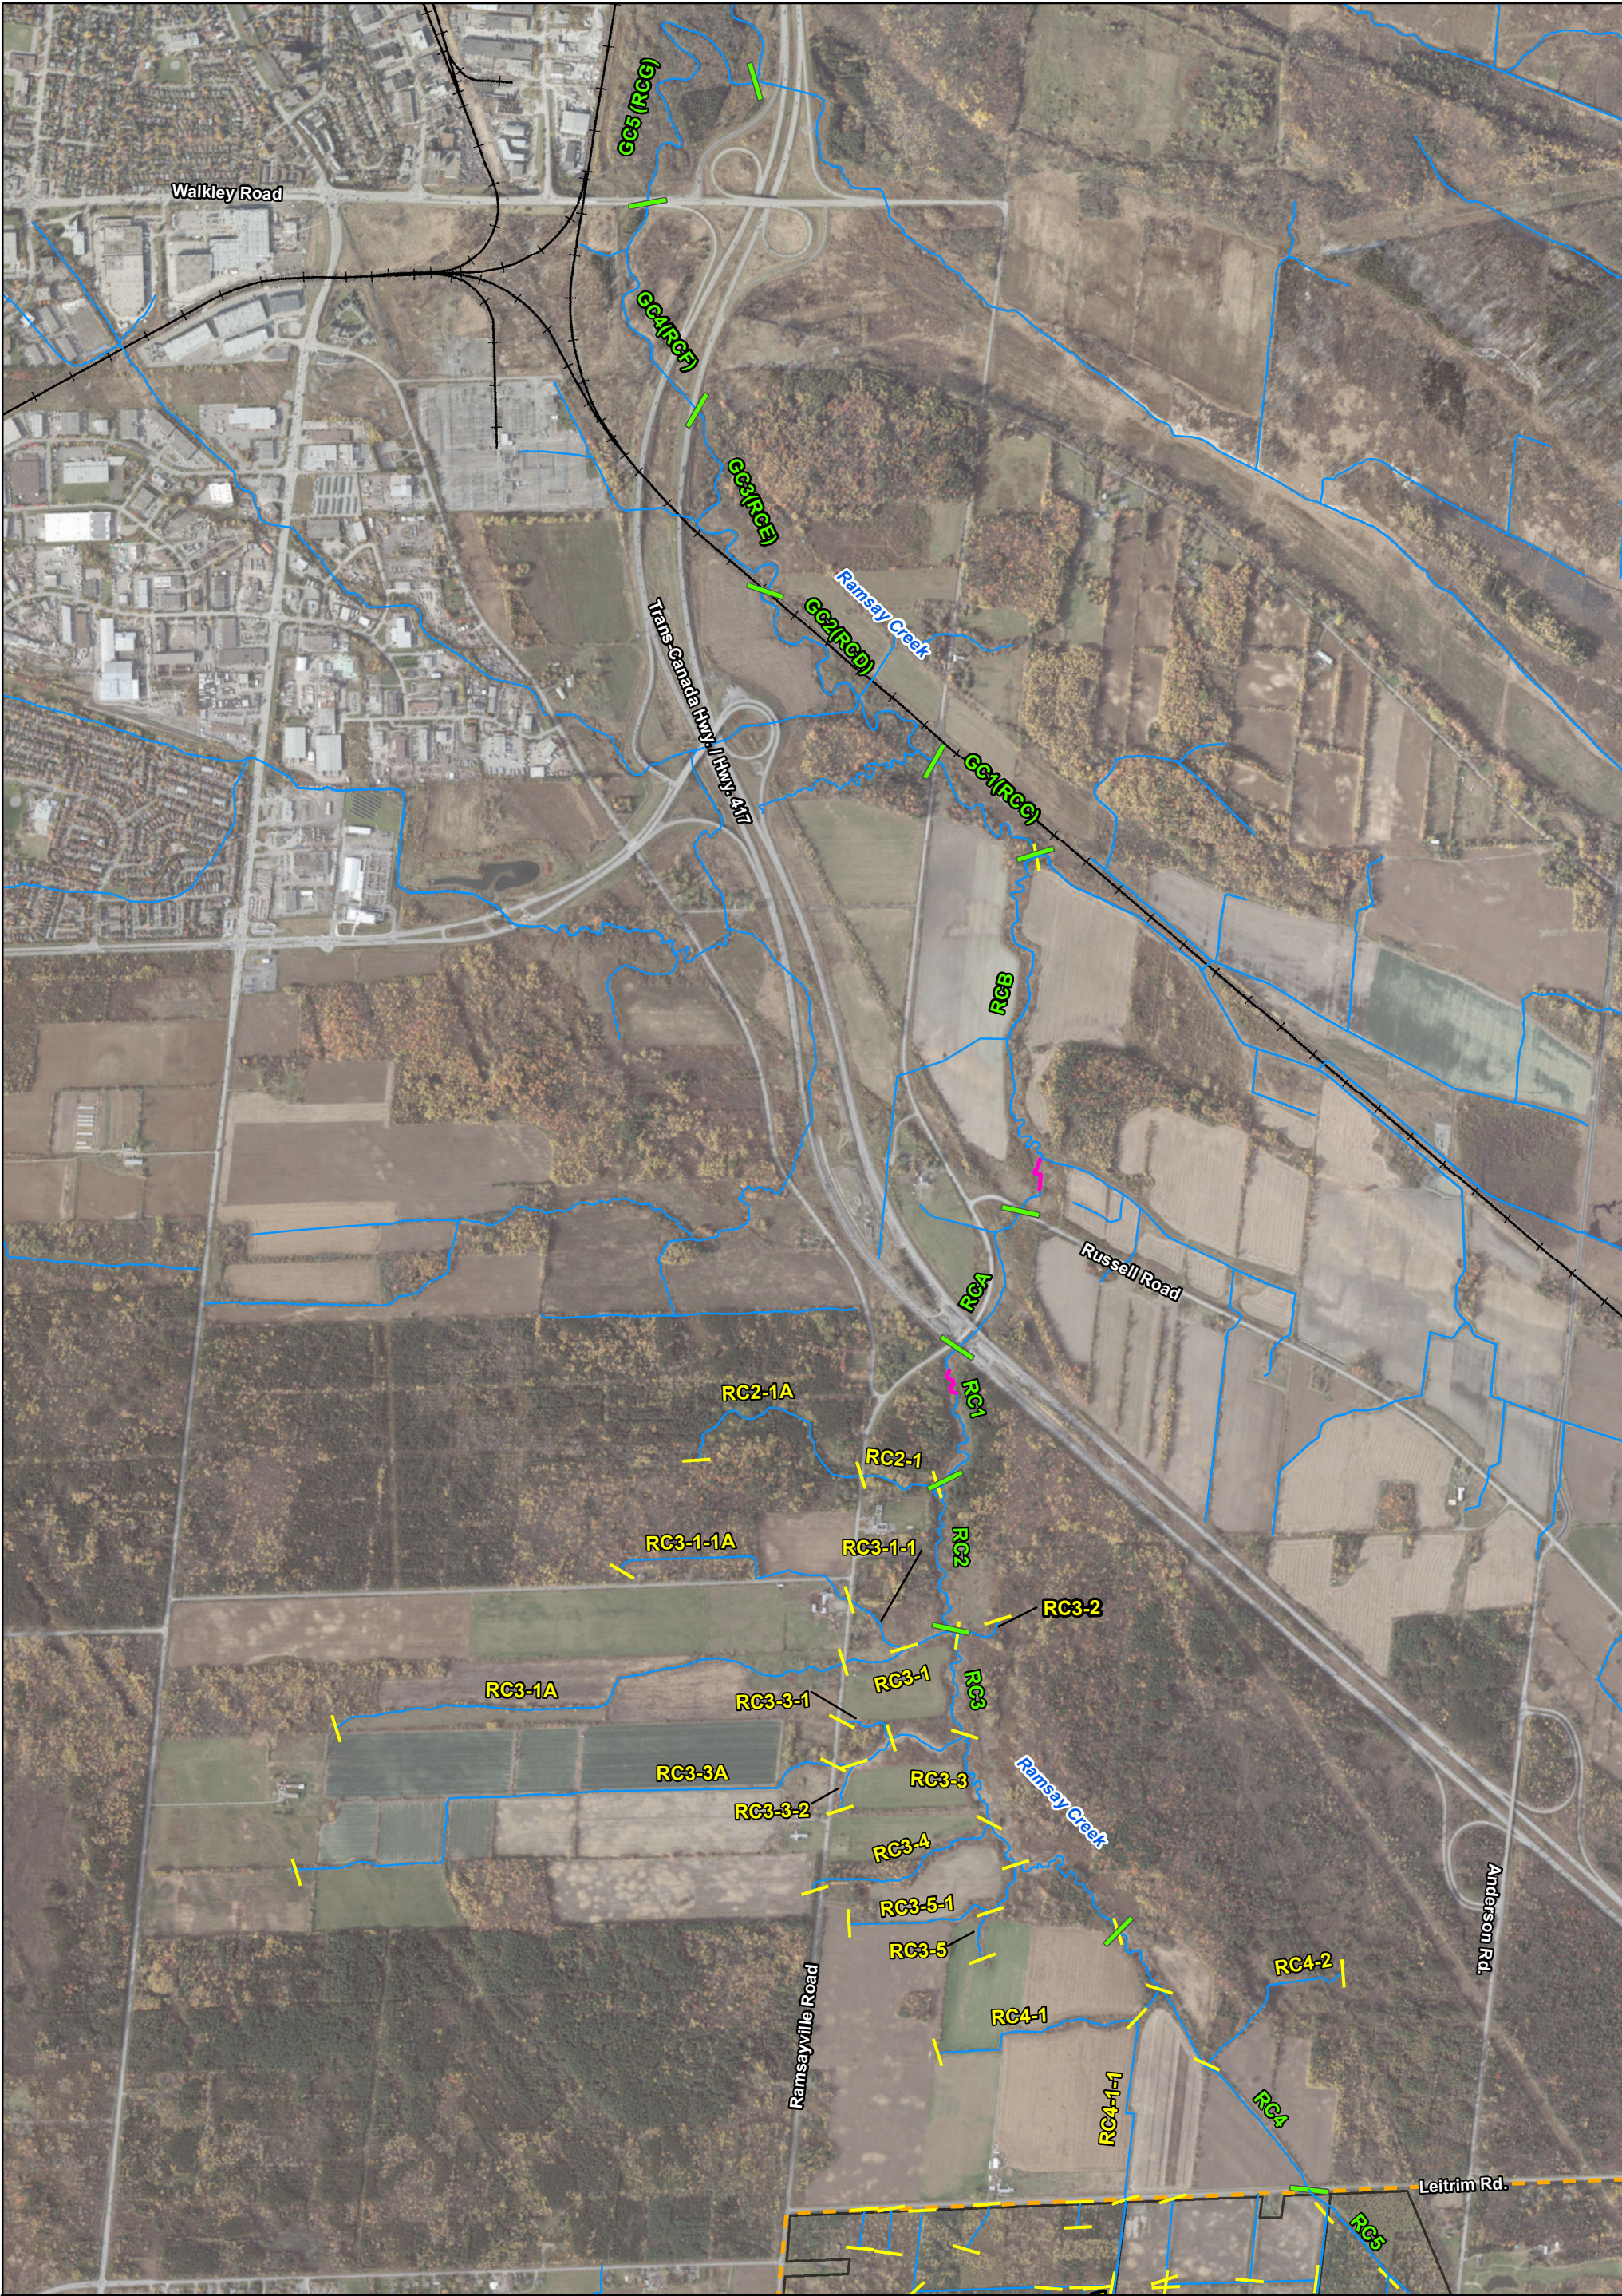
- Legend**
- Reach Break and ID (Tributaries)
 - Reach Break and ID (Main Branch)
 - Watercourse
 - Detailed Assessment Conducted
 - Twin Secondary Plan Area

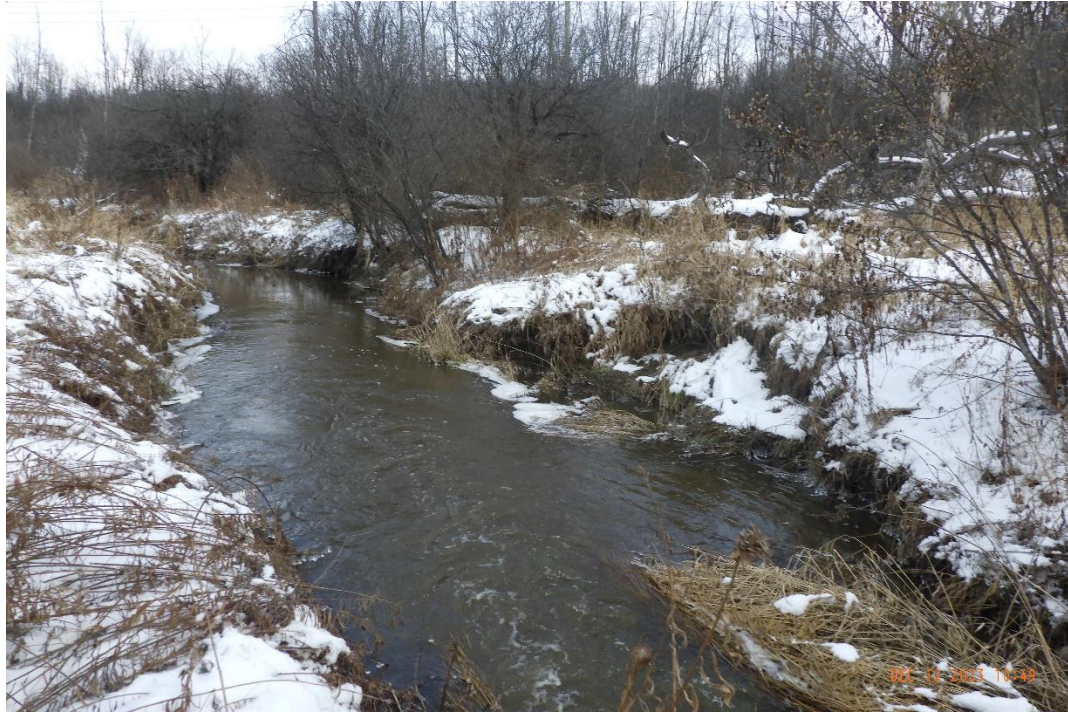
Photo 1

Ramsey Creek- Reach RCA, Ottawa, Ontario

Riffle pool morphology was observed well developed primarily along the downstream portion of the reach.

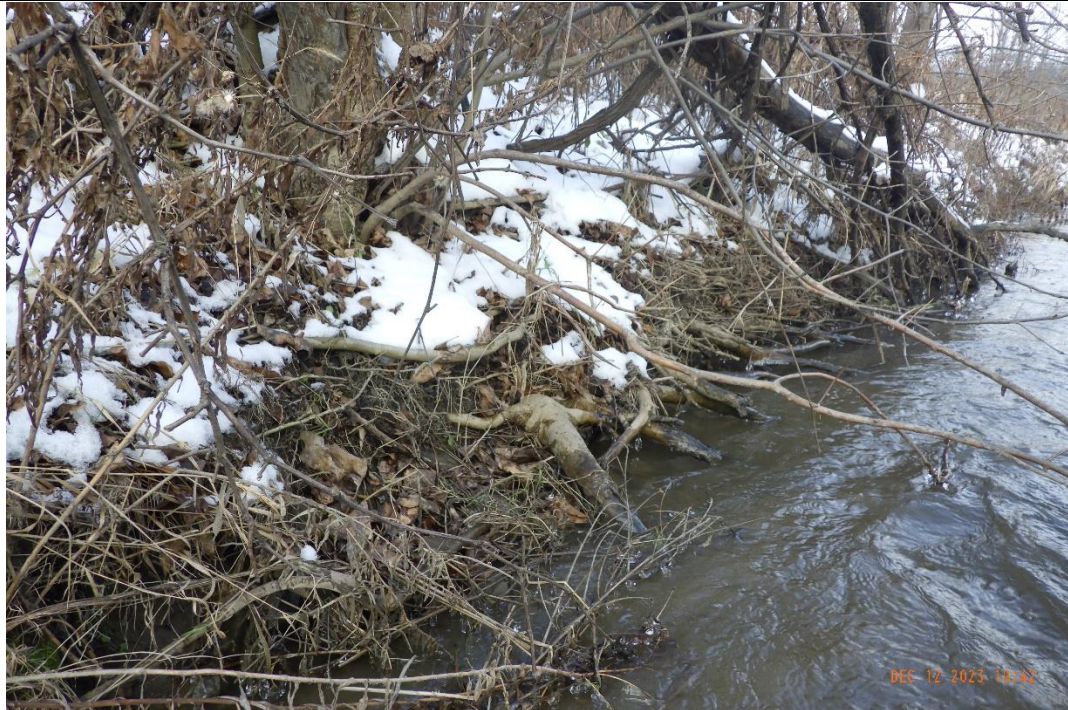
Photo 2

Ramsey Creek- Reach RCA, Ottawa, Ontario

Exposed roots were observed throughout the reach as were fallen and leaning trees.

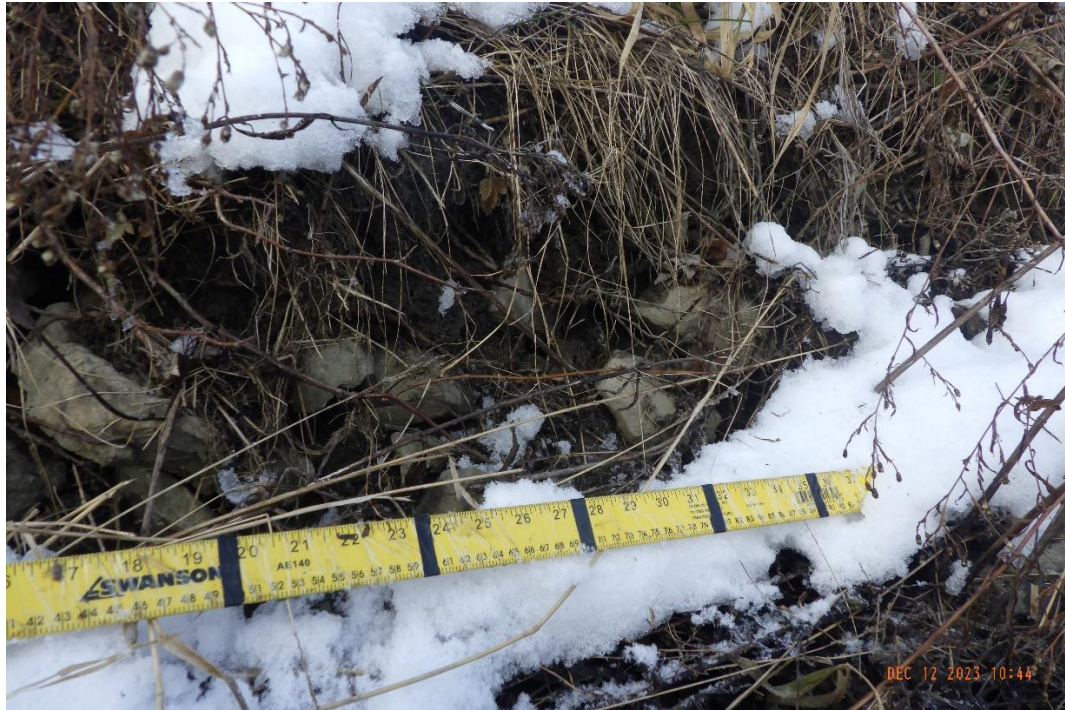
Photo 3
Ramsey Creek- Reach RCA, Ottawa, Ontario

A significant armour layer was identified to be suspended within the banks.

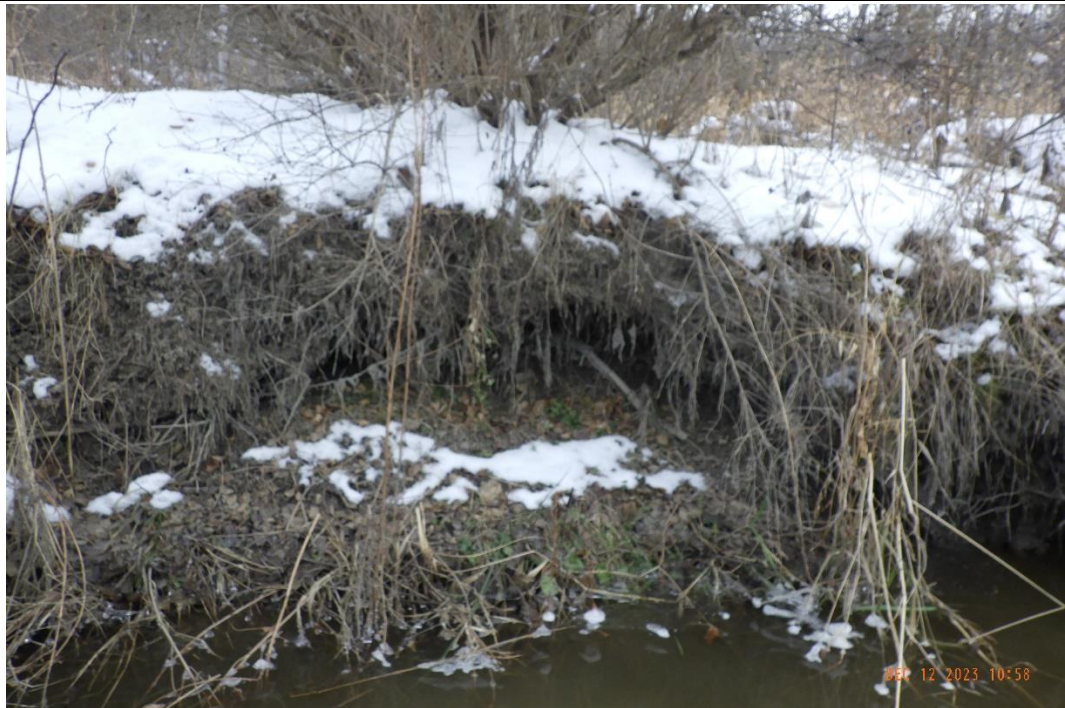
Photo 4
Ramsey Creek- Reach RCA, Ottawa, Ontario

Slumping occurred in localized areas along the reach primarily in the downstream portion. Basal scour was also observed through more than 50% of the reach.

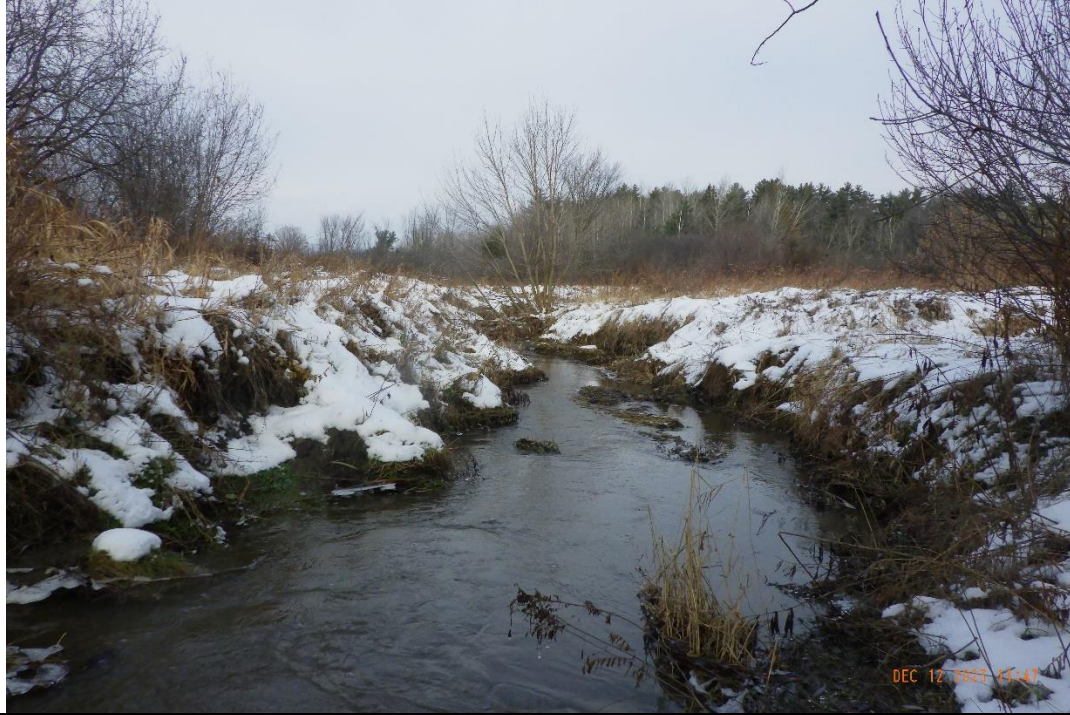
Photo 5
Ramsey Creek- Reach RCB, Ottawa, Ontario

The creek was run dominated with some pools and fewer riffles. Erosion and slumping was present along the banks commonly.

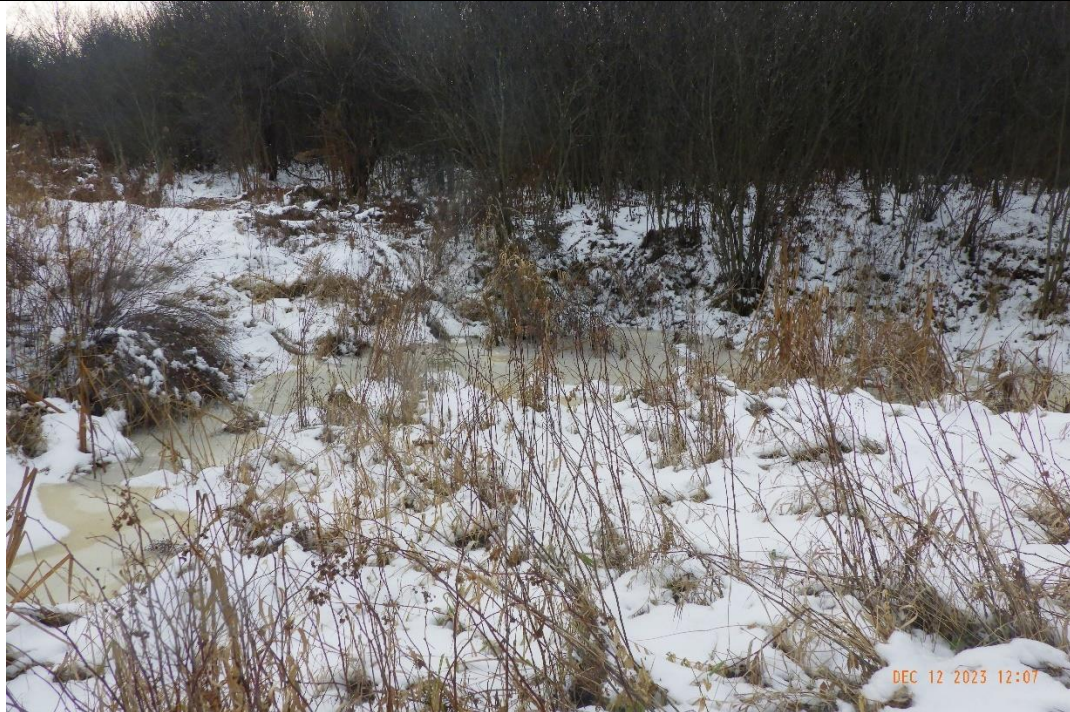
Photo 6
Ramsey Creek- Reach RCB, Ottawa, Ontario

Multiple cutoff channels and old meanders were noted throughout the reach.

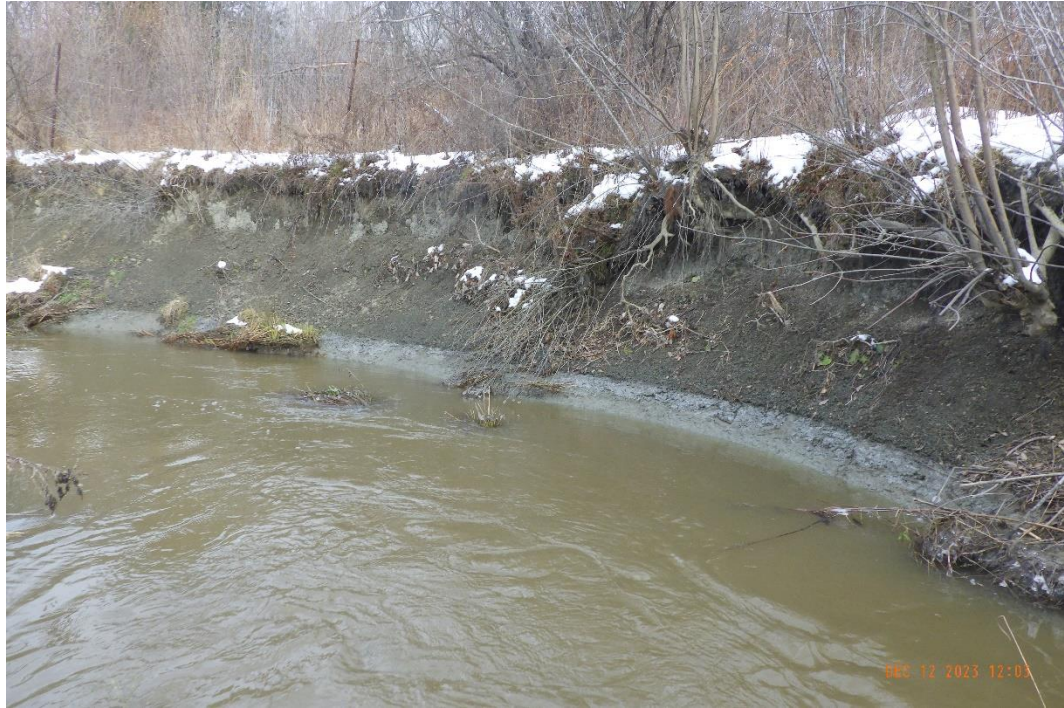
Photo 7
Ramsey Creek- Reach RCB, Ottawa, Ontario

The substrate was observed to consist of clay, silt and sand through the pools and the banks. The few riffles observed generally ranged from clay, silt to cobbles.

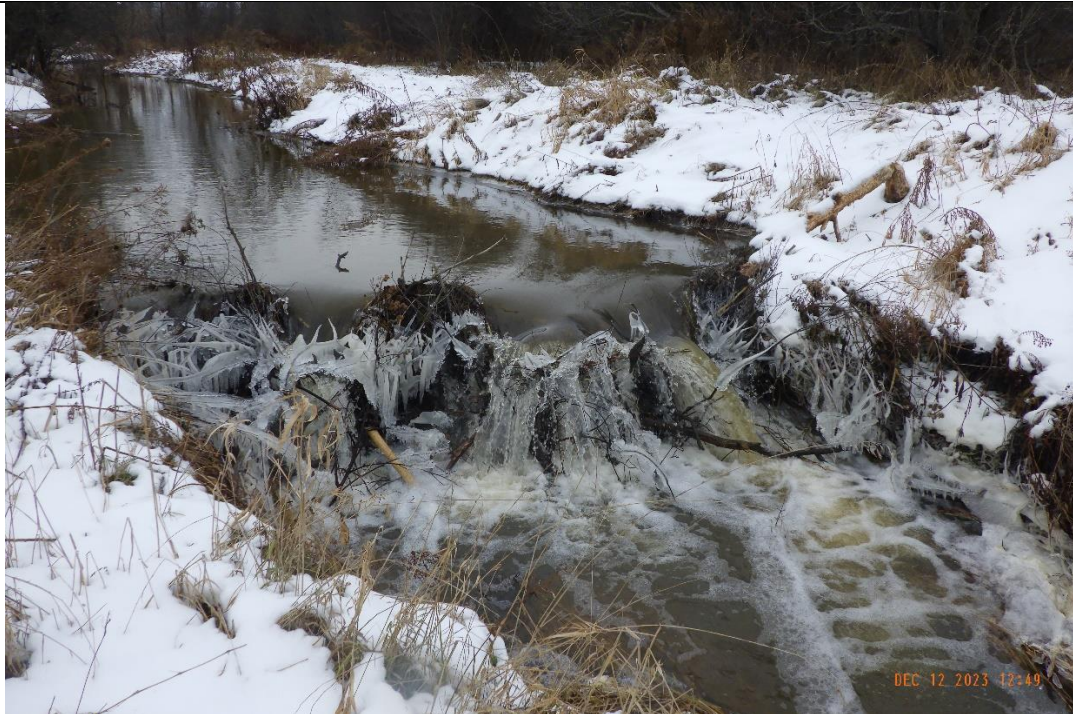
Photo 8
Ramsey Creek- Reach RCB, Ottawa, Ontario

Beaver activity was present throughout this area with observations of pointed tree trunks and beaver dams along the creek.

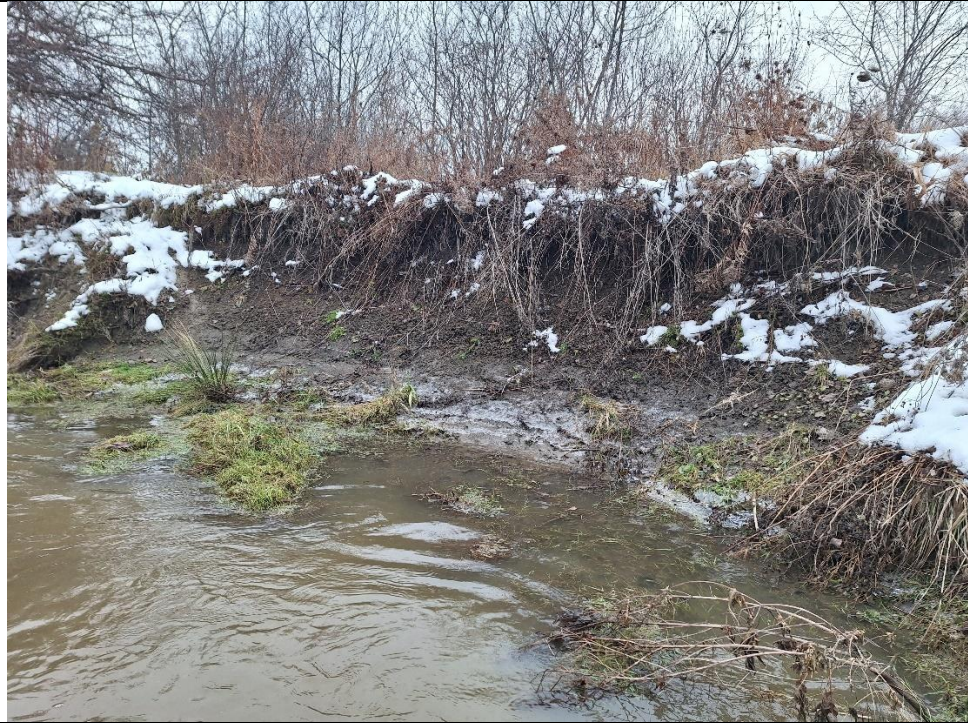
Photo 9

Ramsey Creek- Reach GC1(RCC), Ottawa, Ontario

Basal scour and undercutting were observed throughout more than 50% of the reach with scour occurring along the inside of meander bends and through the riffles.

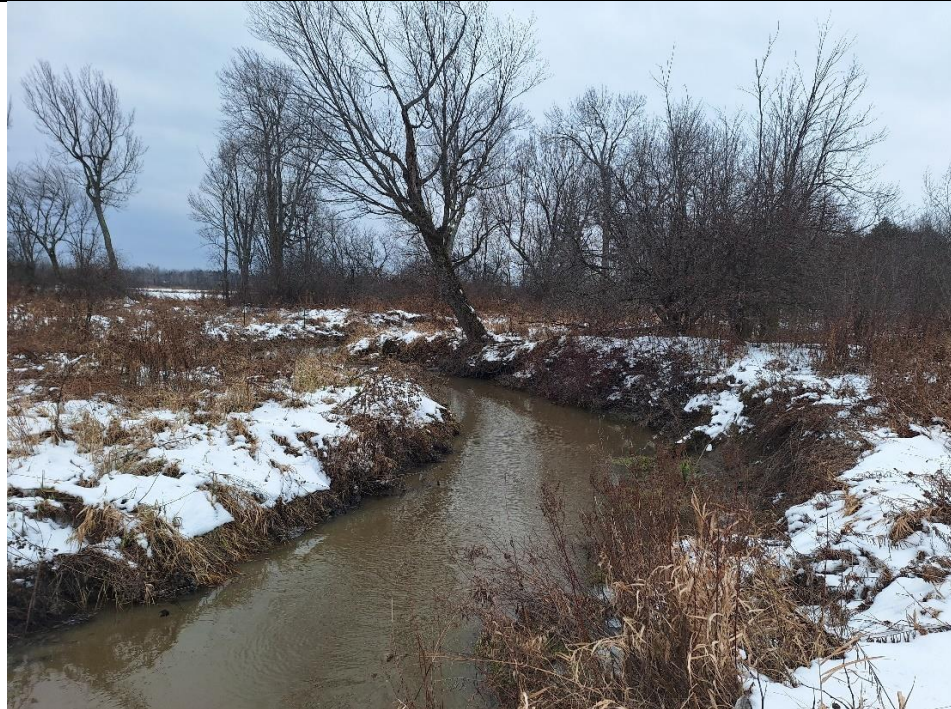
Photo 10

Ramsey Creek- Reach GC1(RCC), Ottawa, Ontario

The creek was observed to be run dominated with turbid water. No odour was detected at the time of site assessment.

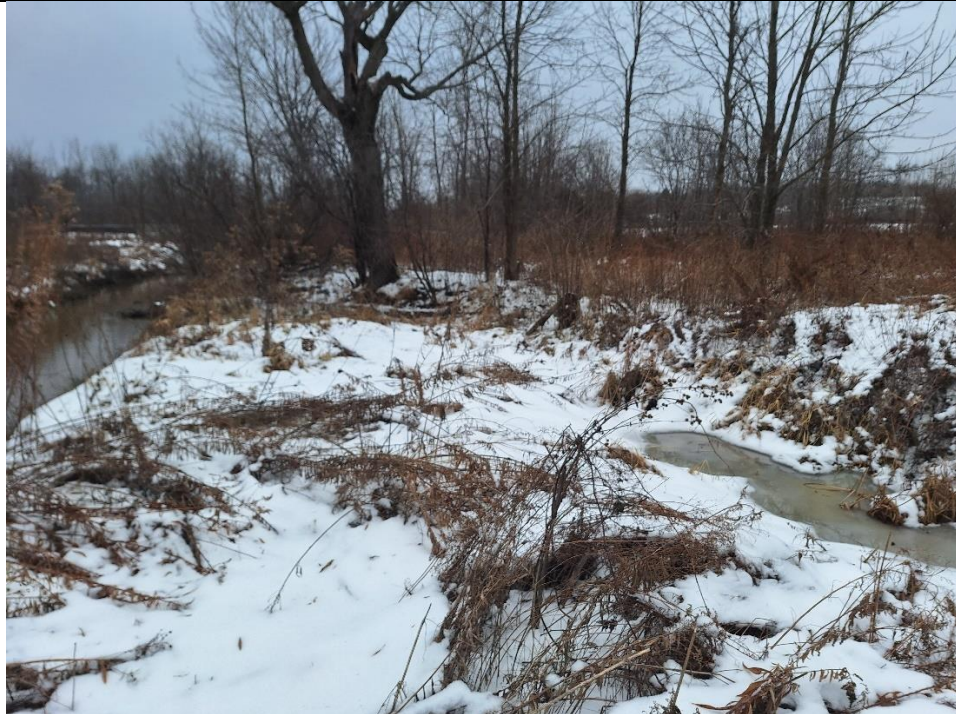
Photo 11

Ramsey Creek- Reach GC1(RCC), Ottawa, Ontario

Midway through the reach a cut off channel was observed at a higher elevation with remnant water present.

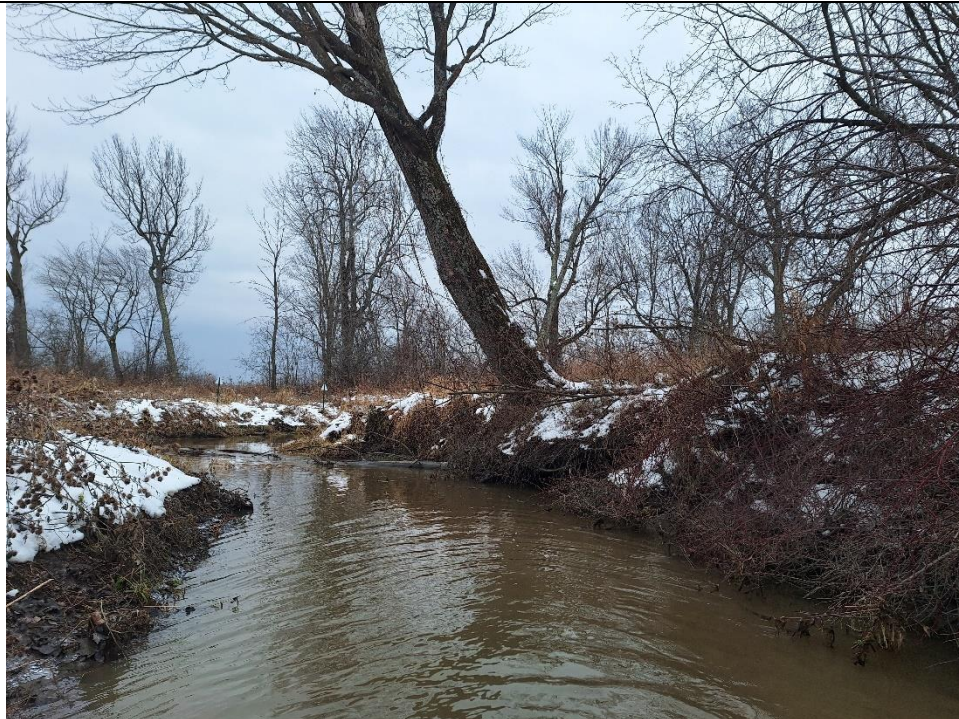
Photo 12

Ramsey Creek- Reach GC1(RCC), Ottawa, Ontario

Leaning and fallen trees, organic debris, and exposed roots were commonly observed throughout the reach.

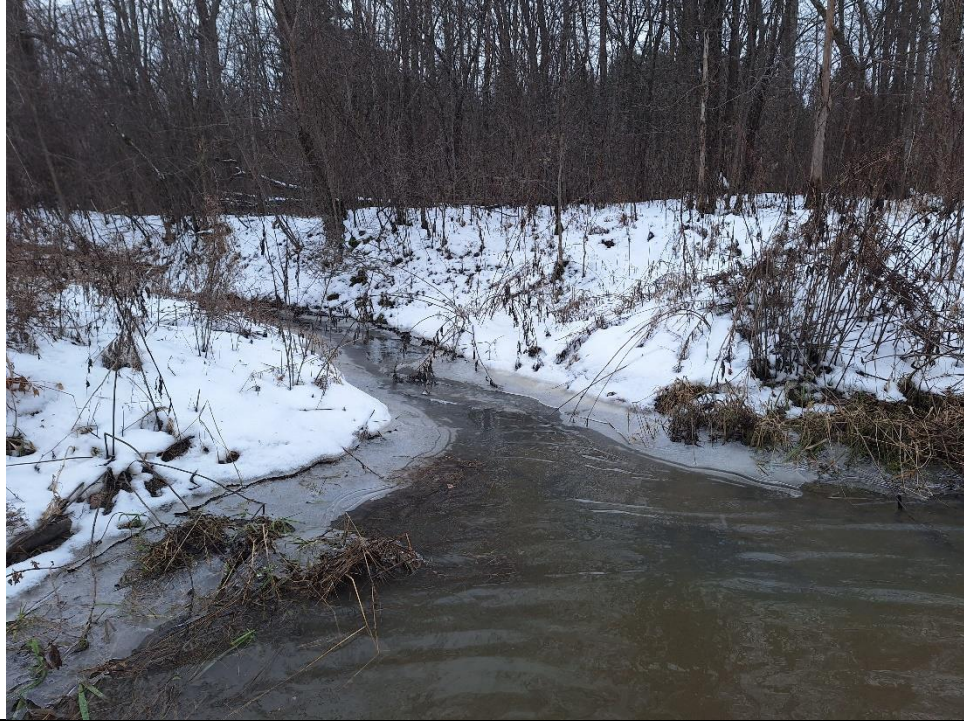
Photo 13

Ramsey Creek- Reach GC2(RCD), Ottawa, Ontario

At the upstream extent of the reach, two tributaries were inputting water to the main channel.

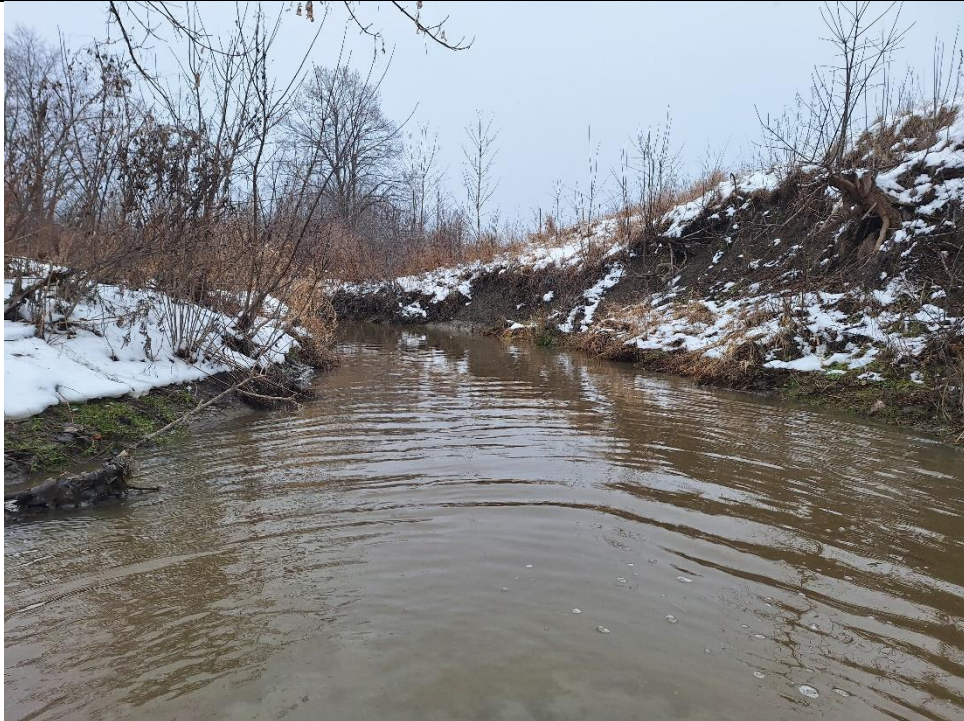
Photo 14

Ramsey Creek- Reach GC2(RCD), Ottawa, Ontario

The channel bank was observed to be eroding adjacent to the train tracks.

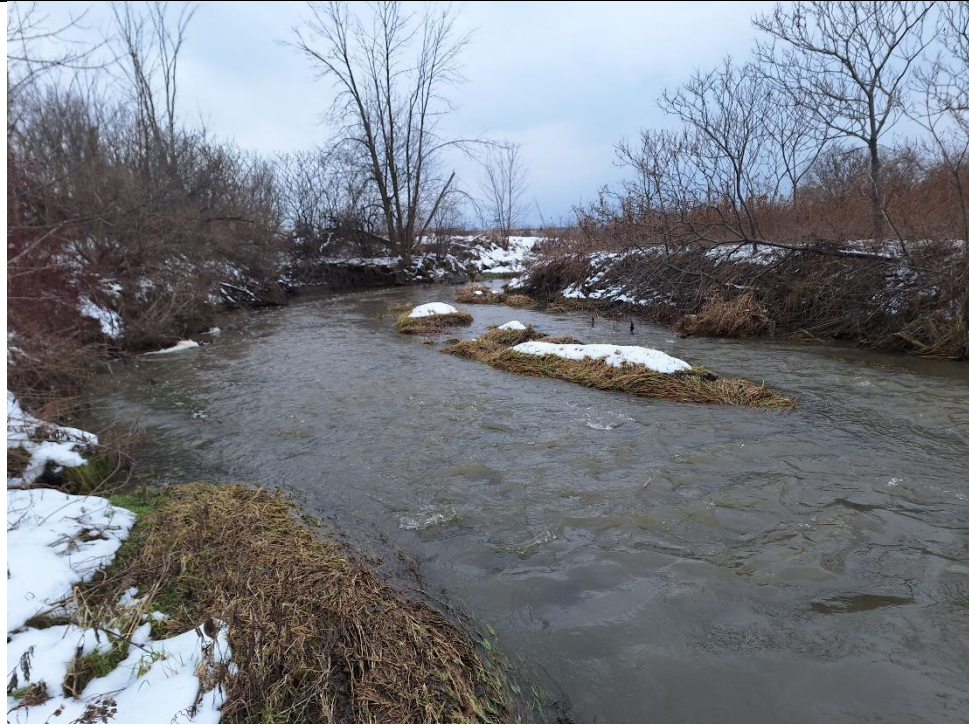
Photo 15

Ramsey Creek- Reach GC2(RCD), Ottawa, Ontario

Riffle pool morphology was not observed except for the depicted one riffle location which was approximately 12 metres long.

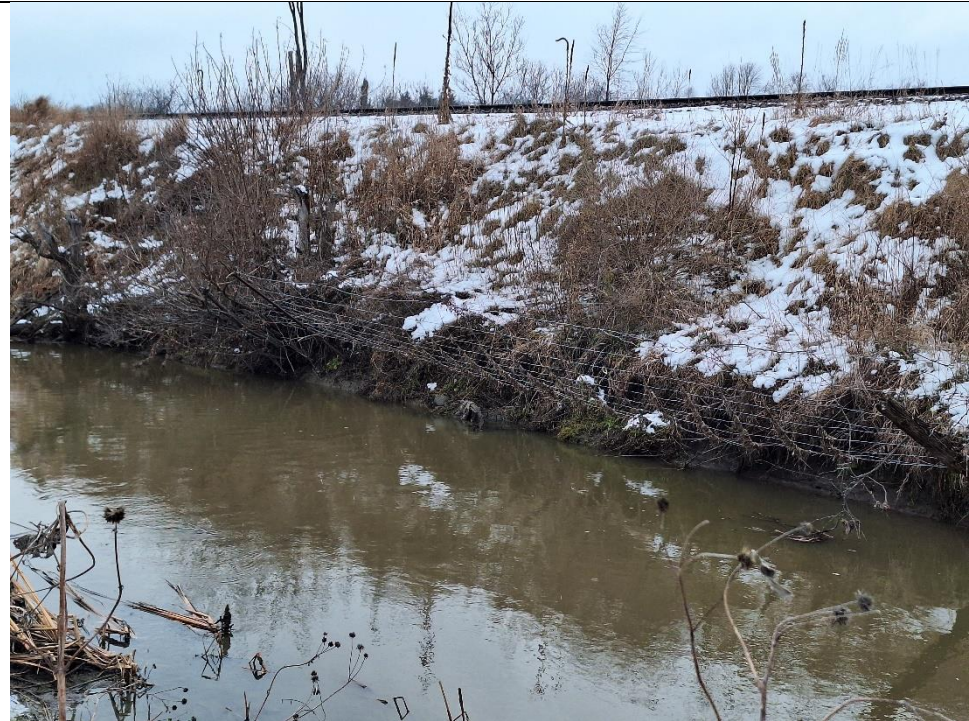
Photo 16

Ramsey Creek- Reach GC2(RCD), Ottawa, Ontario

Undermined fencing was observed along the reach due to erosion and basal scour. Basal scour and undercutting was observed commonly throughout the reach.

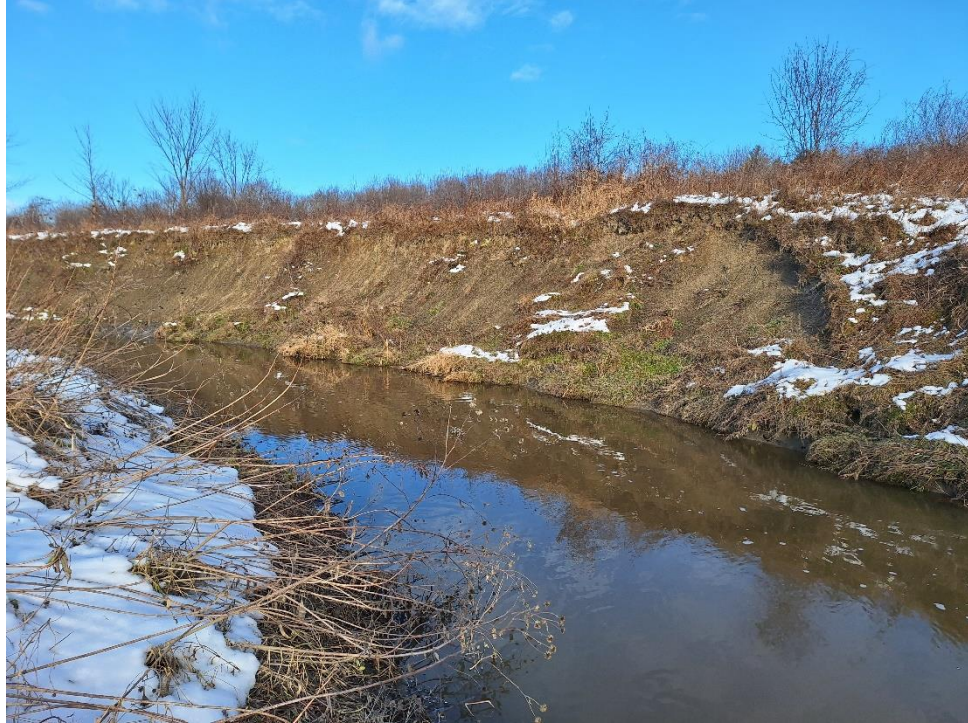
Photo 17

Ramsey Creek- Reach GC3(RCE), Ottawa, Ontario

Large cutfaces were observed where the channel came in contact with the edge of agricultural fields. Basal scour was observed along both banks throughout the reach.

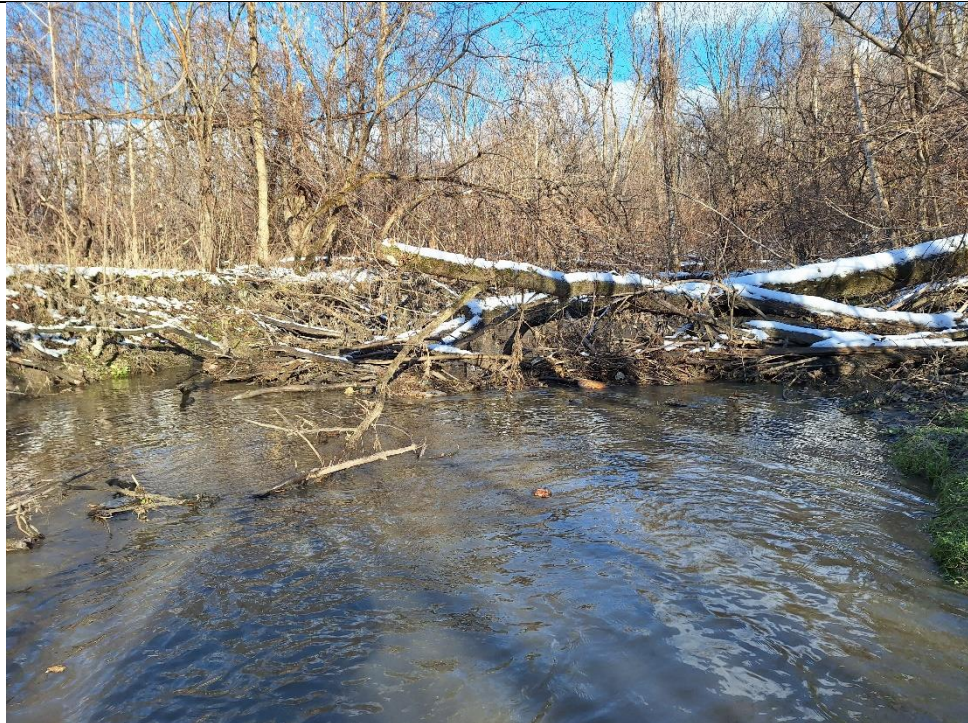
Photo 18

Ramsey Creek- Reach GC3(RCE), Ottawa, Ontario

Large woody debris and down trees became more frequent relative to upstream reaches.

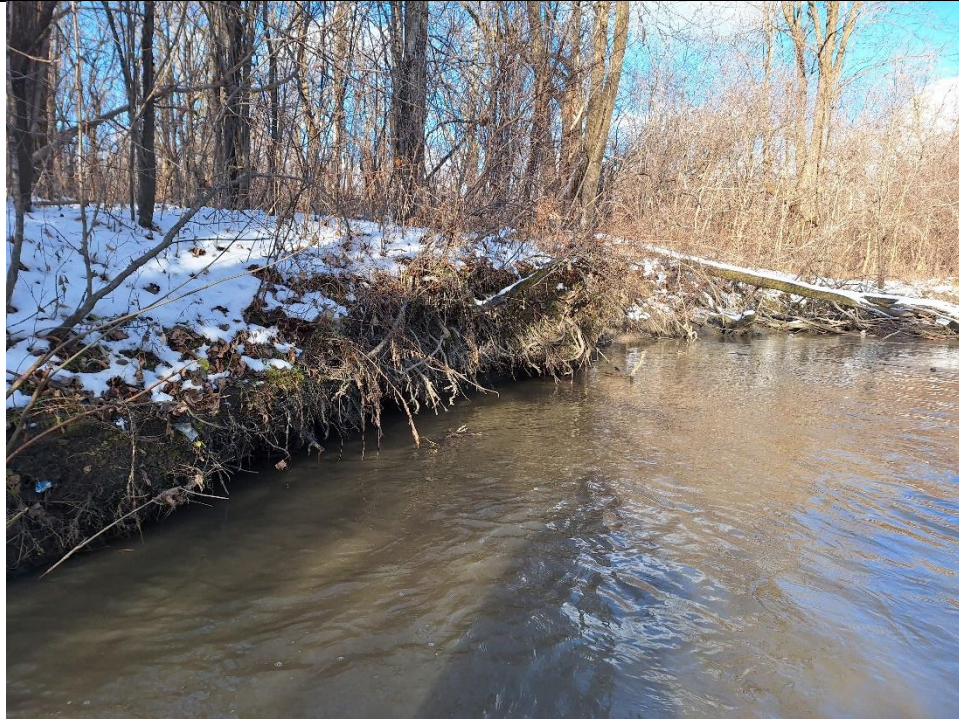
Photo 19

Ramsey Creek- Reach GC3(RCE), Ottawa, Ontario

Undercutting and exposed roots was observed at several locations along the reach. The channel substrate was composed of fine silts over compact clay.

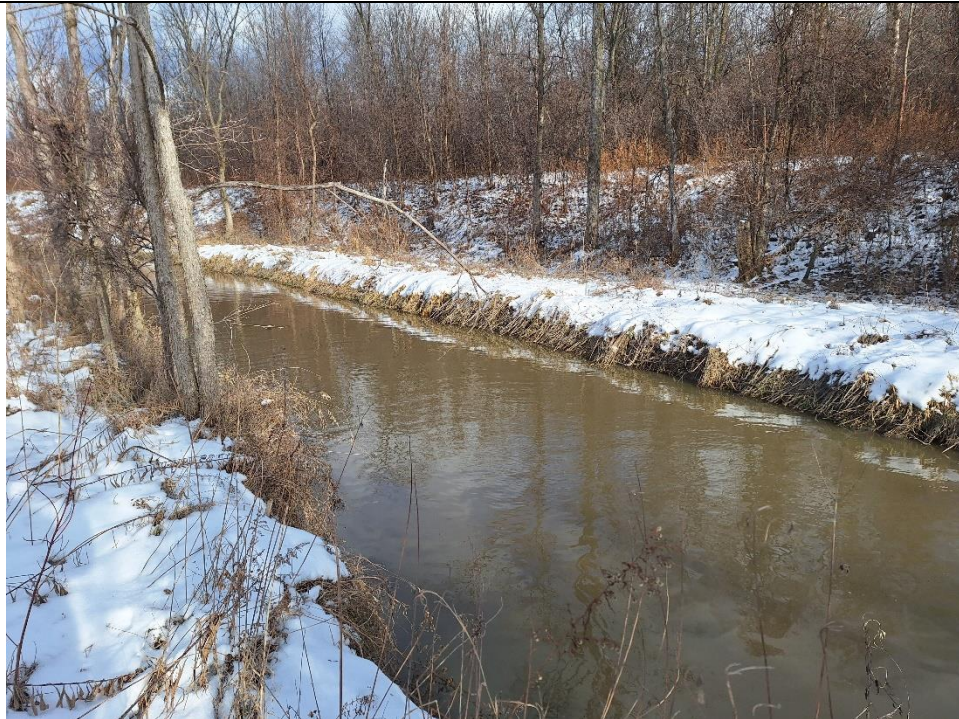
Photo 20

Ramsey Creek- Reach GC3(RCE), Ottawa, Ontario

The downstream extent of the reach had grassy banks and exhibited a wide flat floodplain within a partially confined valley. The channel was dominated with runs and lack riffle-pool features.

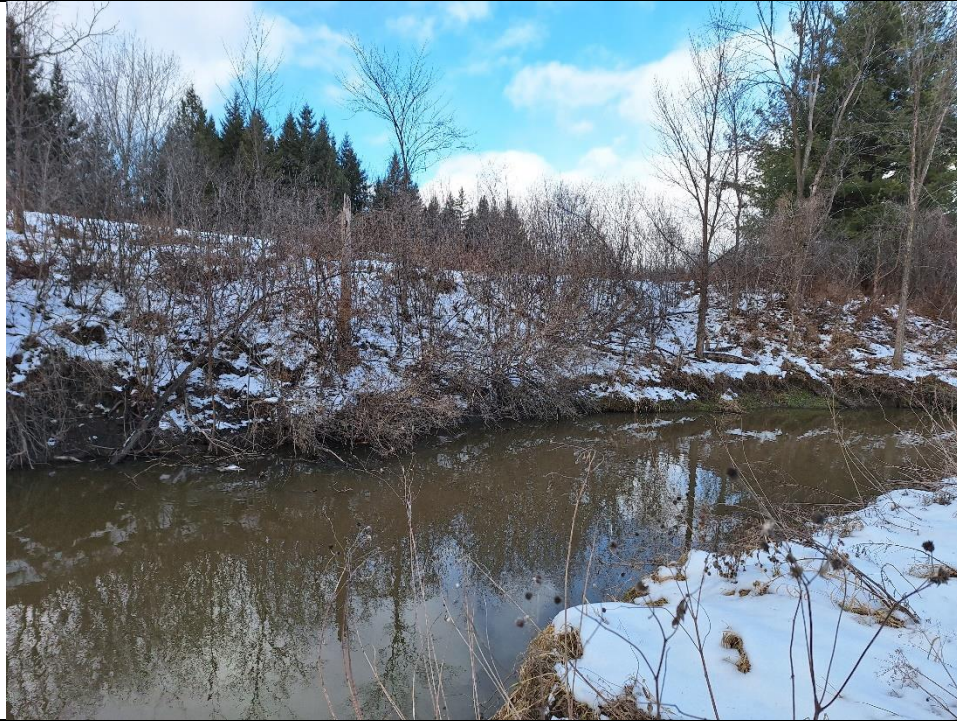
Photo 21

Ramsey Creek- Reach GC4(RCF), Ottawa, Ontario

Throughout the reach, scour was observed, however not as continuous as observed at upstream reaches. The reach was dominated by runs and lacked riffle-pool features.

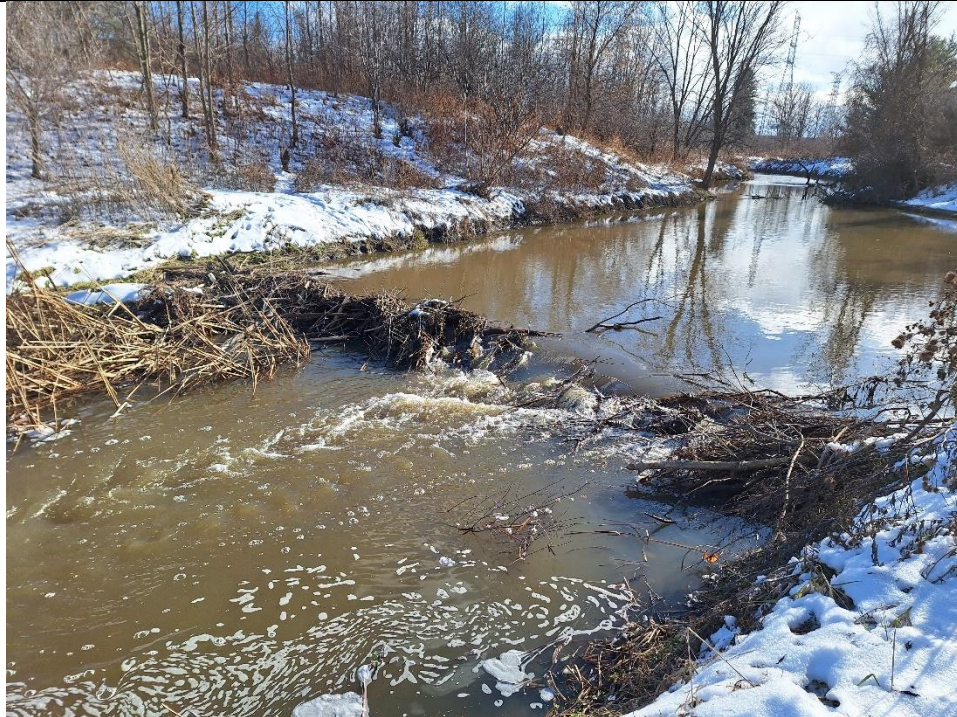
Photo 22

Ramsey Creek- Reach GC4(RCF), Ottawa, Ontario

A large beaver dam was observed towards the downstream extent of the reach, causing backwater. Extensive evidence of beaver activity was observed throughout the reach.

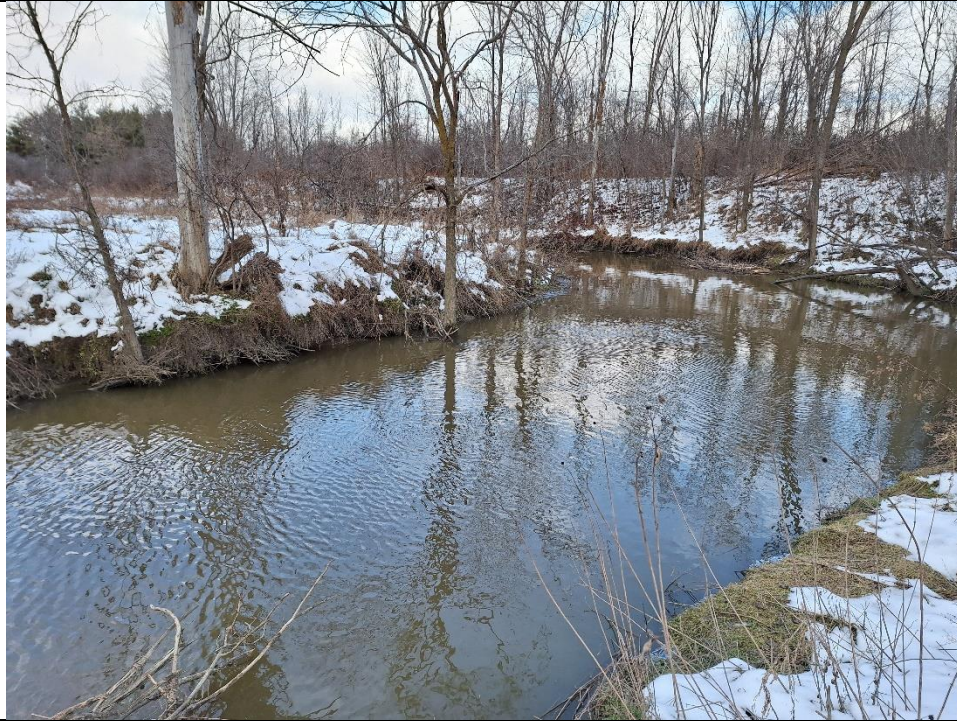
Photo 23

Ramsey Creek- Reach GC4(RCF), Ottawa, Ontario

Undercutting was observed at 1-2 locations along the reach. Concentrated along inside banks. Exposed tree roots were commonly observed.

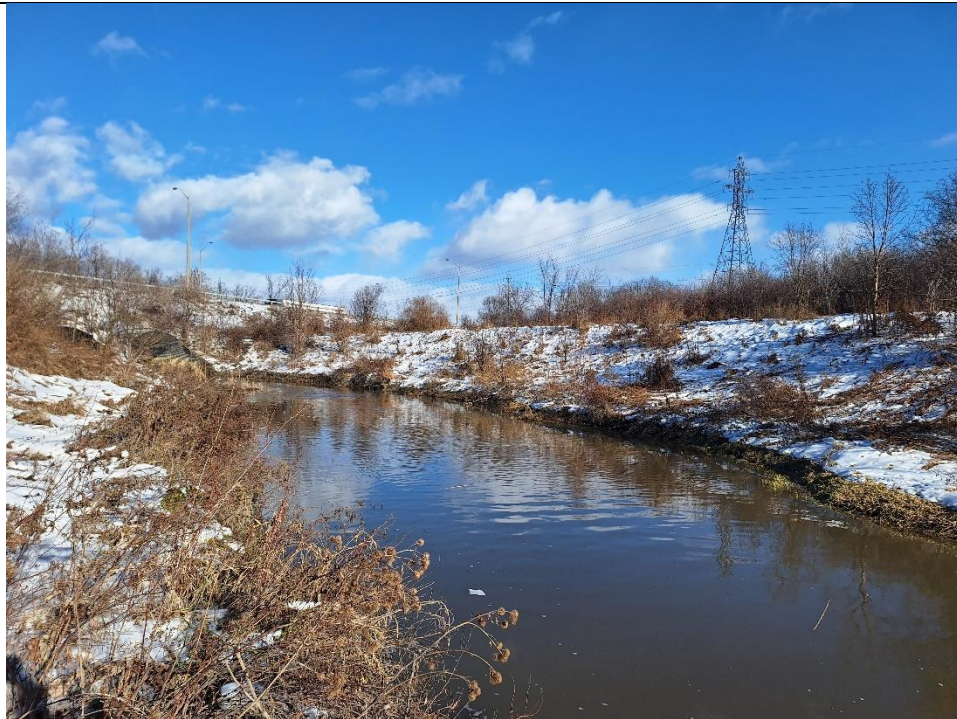
Photo 24

Ramsey Creek- Reach GC4(RCF), Ottawa, Ontario

Towards the downstream extent, the channel banks were well vegetated with little signs of erosion. The channel substrate was composed of fine silts over compact clay.

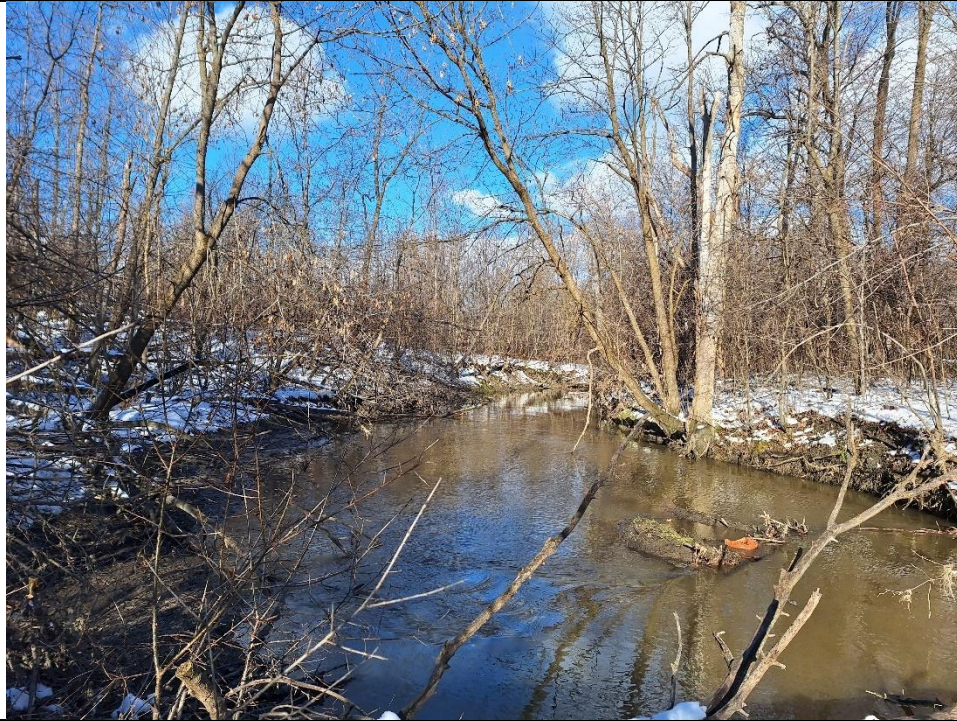
Photo 25

Ramsey Creek- Reach GC5(RCG), Ottawa, Ontario

The reach travels within a forested area, leaning trees and exposed roots were commonly observed. The channel exhibited a meandering planform and was dominated by runs.
