**Re: Background Review and Drainage Characterization of Ramsay Creek
Tewin Secondary Plan Area
City of Ottawa, Ontario
GEO Morphix Project No. 21063**

**Ramsay Creek
Reach Delineation**

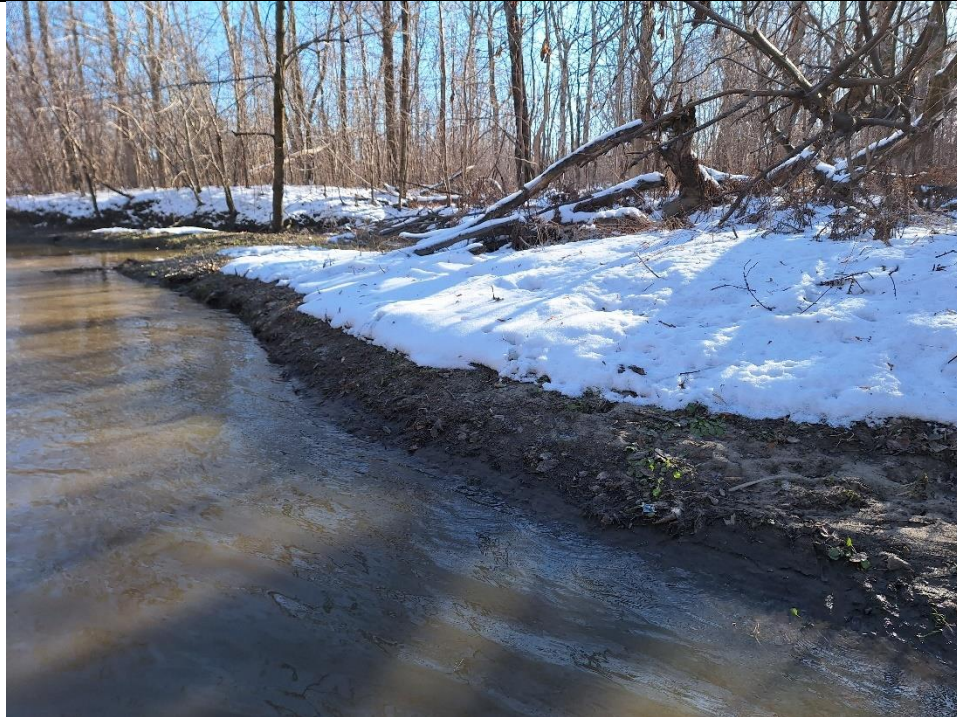
Photo 26

Ramsey Creek- Reach GC5(RCG), Ottawa, Ontario

Point bars were commonly observed along the inside meanders, most appeared stable, and a few were vegetated. The channel substrate was composed of clay and silt.

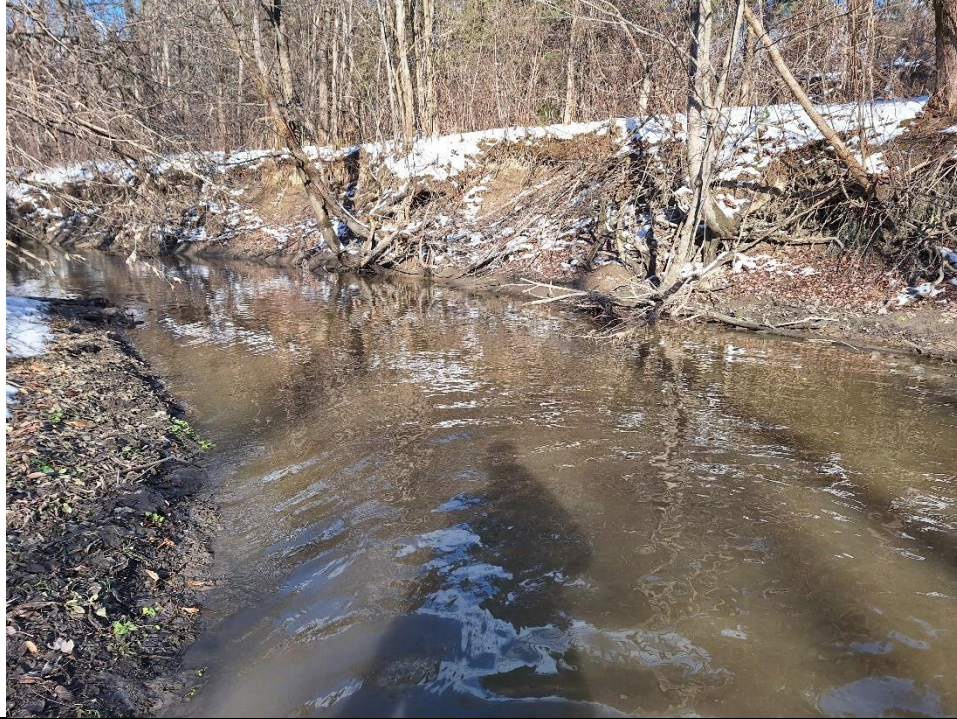
Photo 27

Ramsey Creek- Reach GC5(RCG), Ottawa, Ontario

Valley wall contact along outside meanders were observed at several locations along the reach.

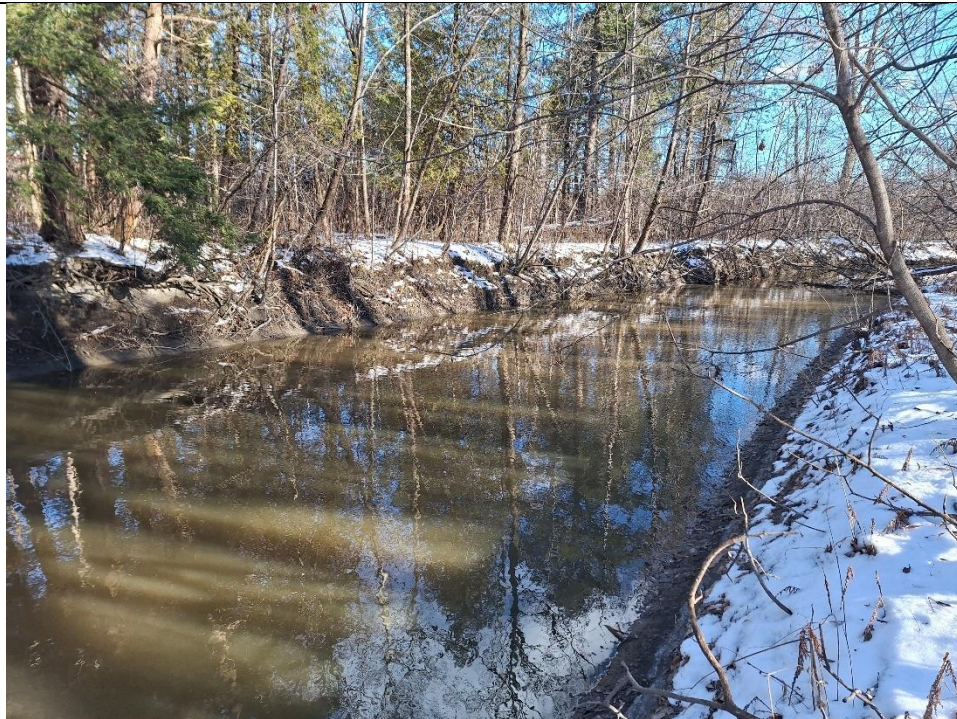
Photo 28

Ramsey Creek- Reach GC5(RCG), Ottawa, Ontario

The downstream extent of the reach exhibited a straight planform and tall vertical banks.

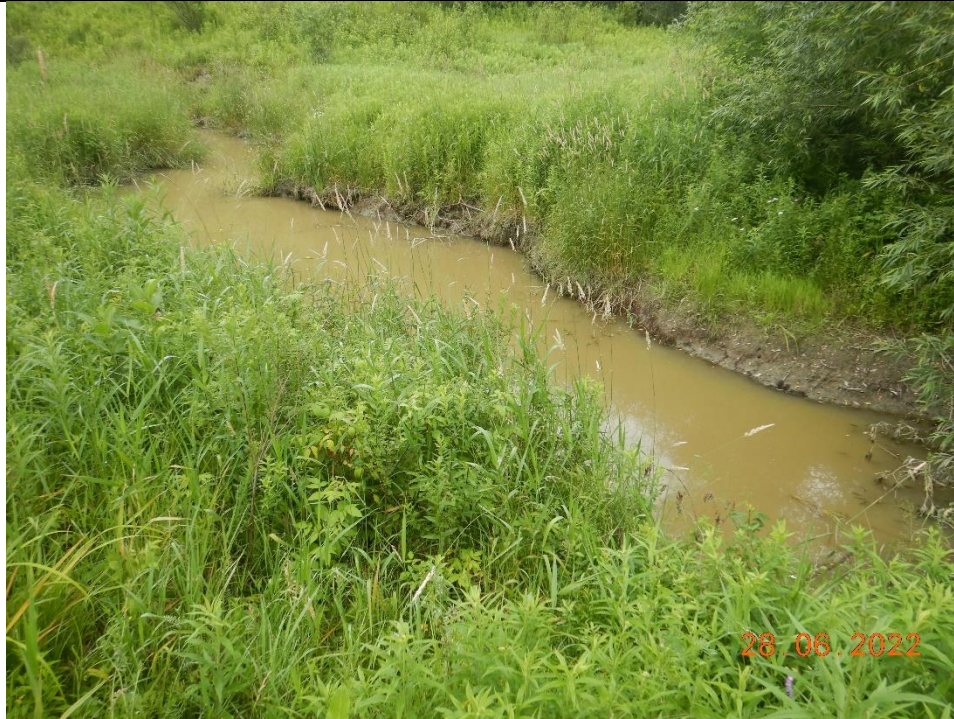
Photo 29
Ramsey Creek- Reach RC1, Ottawa, Ontario

The reach exhibited a meandering planform throughout a large grassy meadow. The banks were well vegetated.

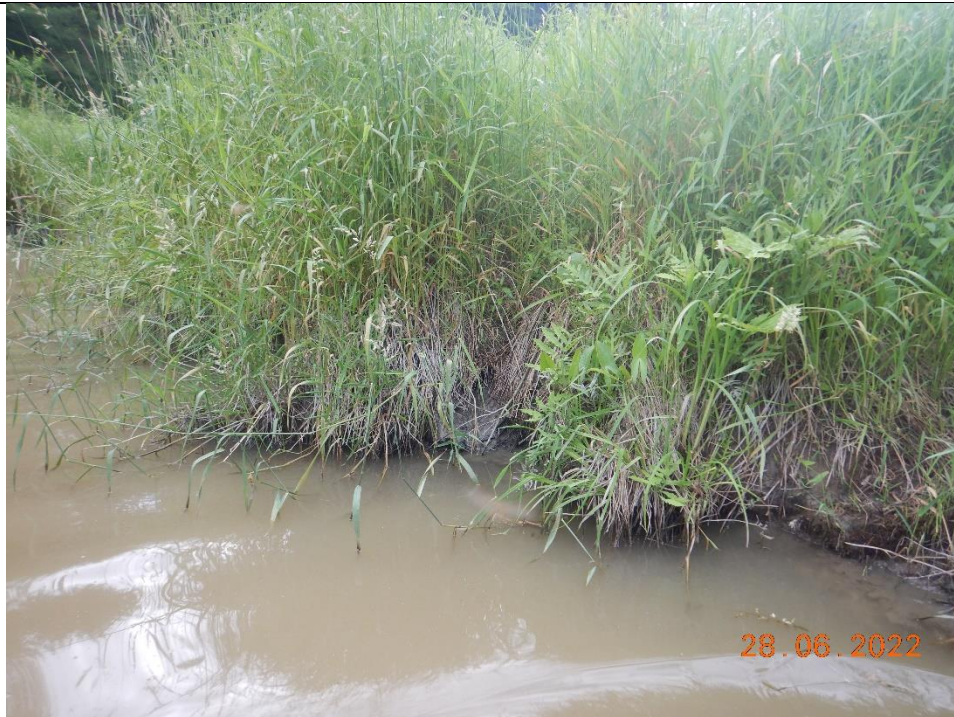
Photo 30
Ramsey Creek- Reach RC1, Ottawa, Ontario

Slumping was commonly observed throughout the banks on both sides of the channel.

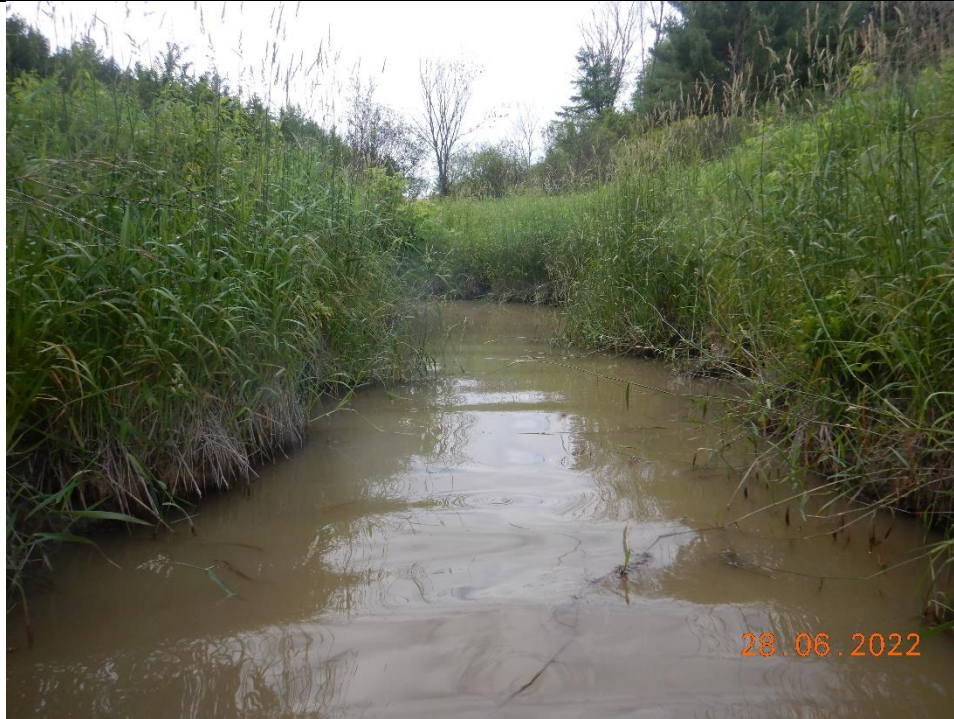
Photo 31
Ramsey Creek- Reach RC1, Ottawa, Ontario

The reach was dominated by runs and no pool-riffle formations were observed. The water was turbid at the time of the assessment.

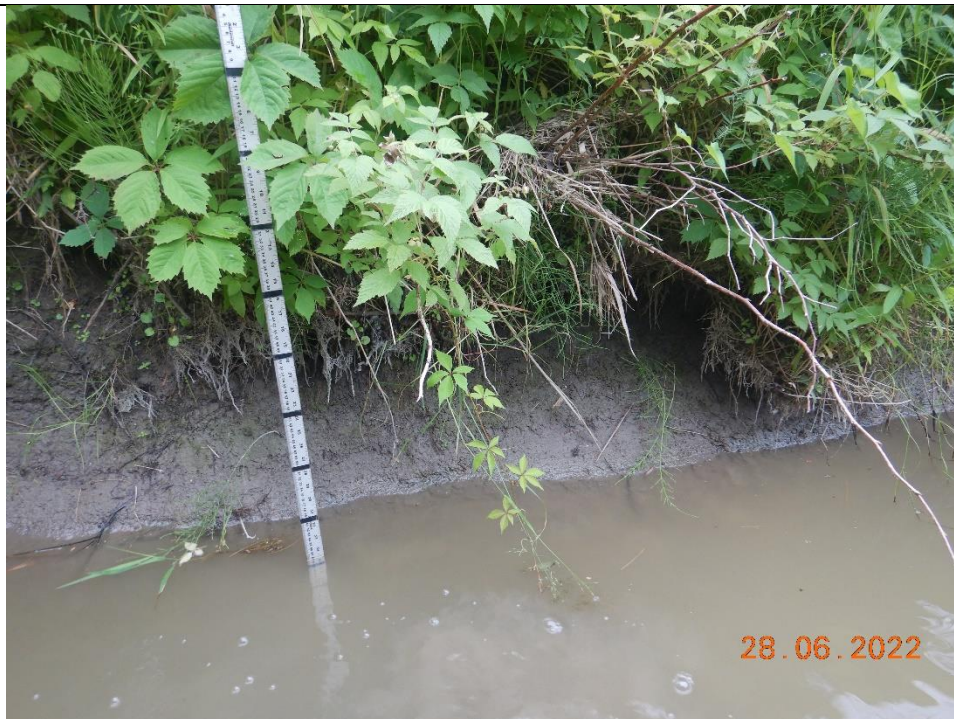
Photo 32
Ramsey Creek- Reach RC1, Ottawa, Ontario

Minor basal scour was common throughout the reach. The channel substrate was composed of fine silt over compact clays.

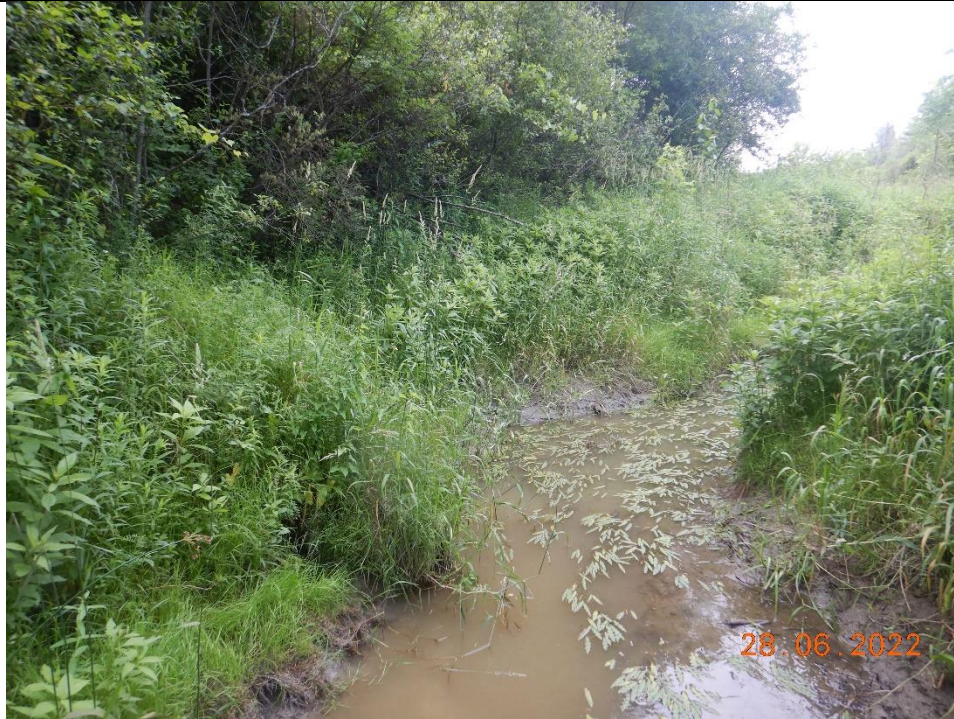
Photo 33
Ramsey Creek- Reach RC2, Ottawa, Ontario

The reach exhibits a meandering planform through a large meadow. The riparian zone is primarily grasses and the banks were well vegetated. The reach was dominated by runs.

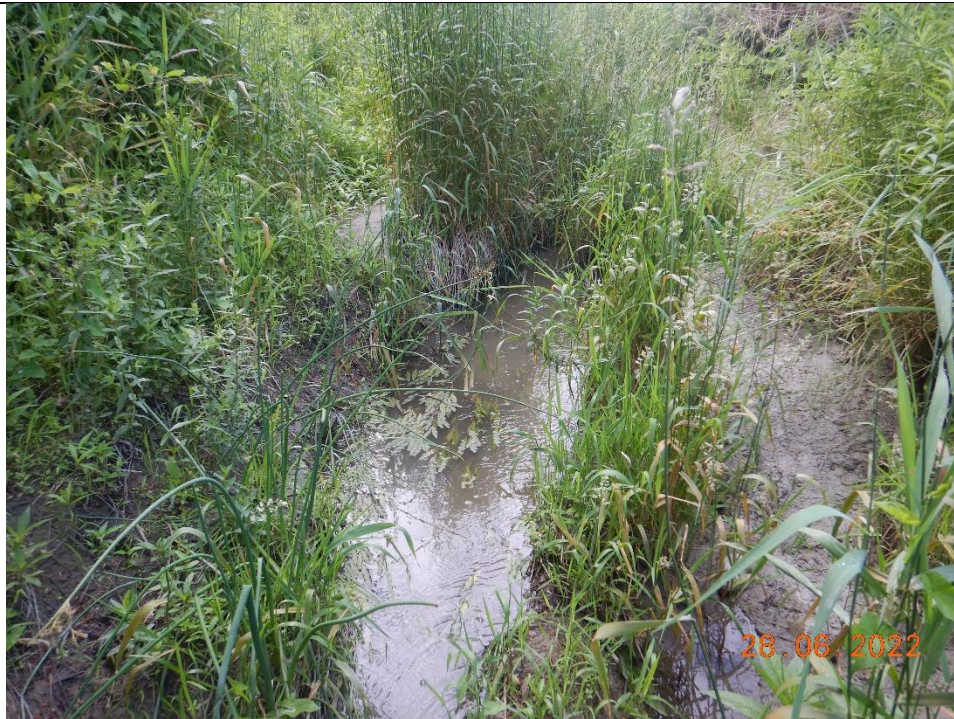
Photo 34
Ramsey Creek- Reach RC2, Ottawa, Ontario

Instream vegetation was observed throughout the reach, and vegetation encroachment was heavy. Overbank deposition was observed at several locations along the downstream extent.

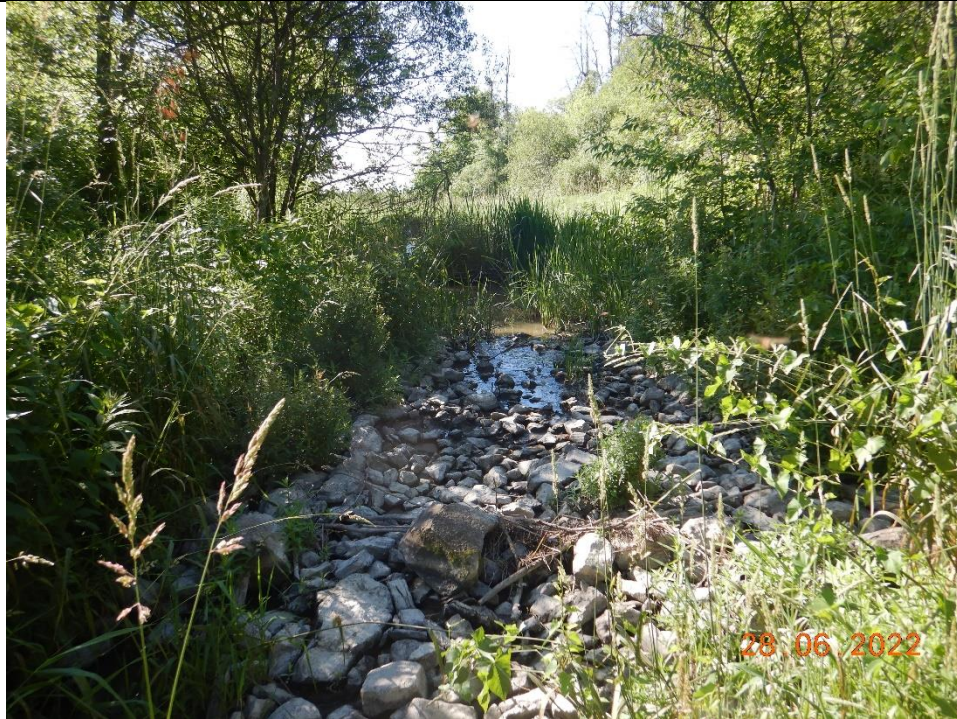
Photo 35
Ramsey Creek- Reach RC2, Ottawa, Ontario

Placed cobbles were observed halfway through the reach. This caused a back water effect upstream, where the channel is wide a flat.

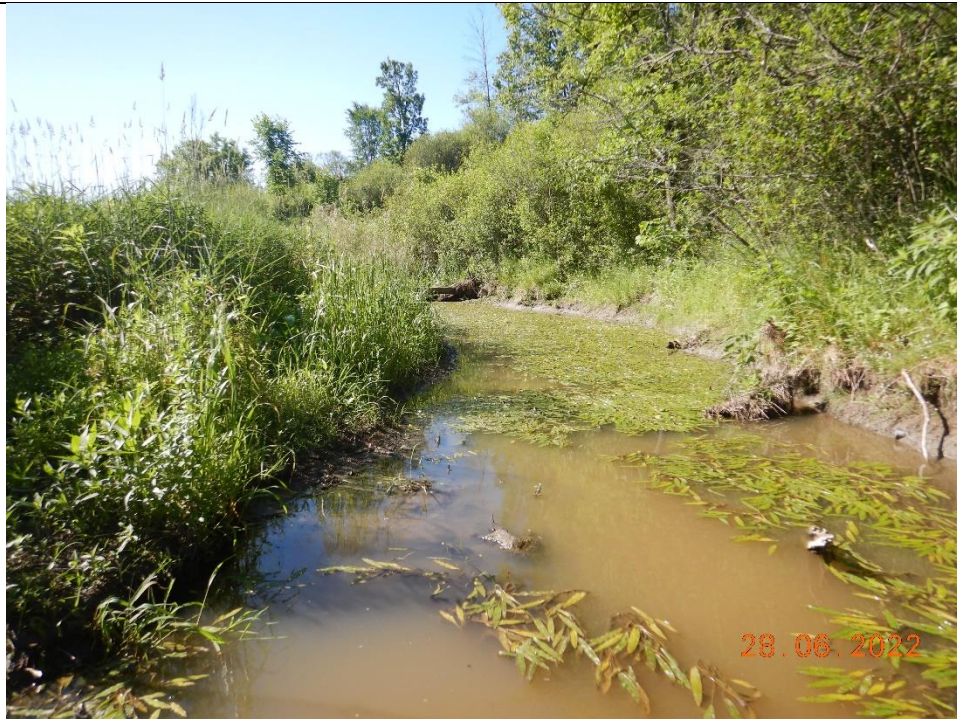
Photo 36
Ramsey Creek- Reach RC2, Ottawa, Ontario

Minor basal scour was commonly observed along on or both banks at the upstream extent of the reach. The channel bed substrate throughout the reach was composed of fine silt over compact clay.

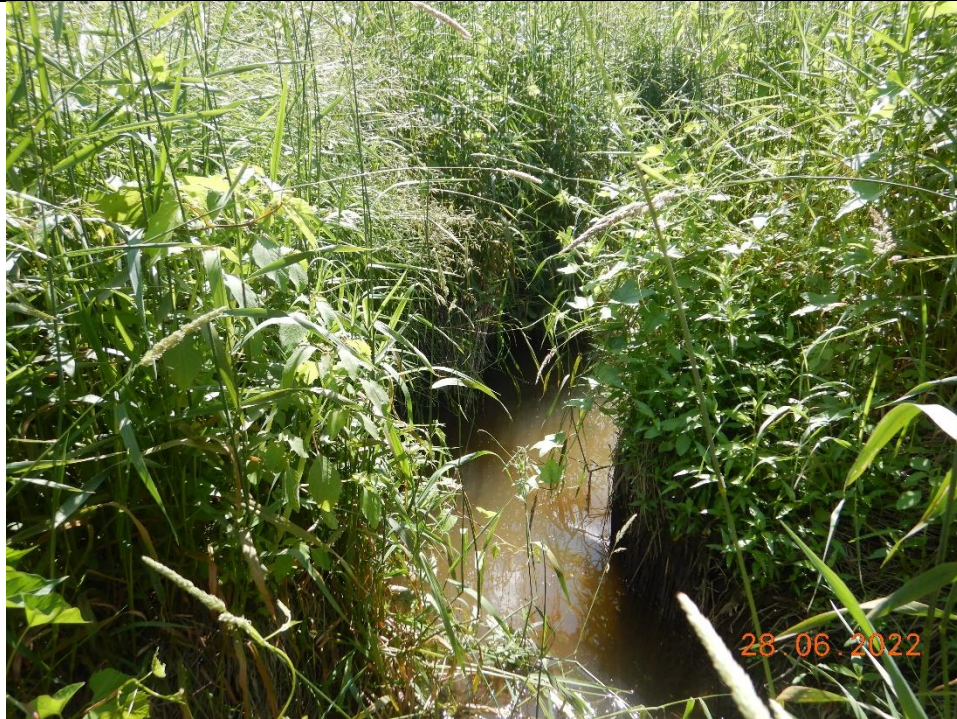
Photo 37
Ramsey Creek- Reach RC3, Ottawa, Ontario

The reach meanders through a large grassy meadow and had well vegetated banks. Vegetation encroachment was moderate to extreme in some locations.

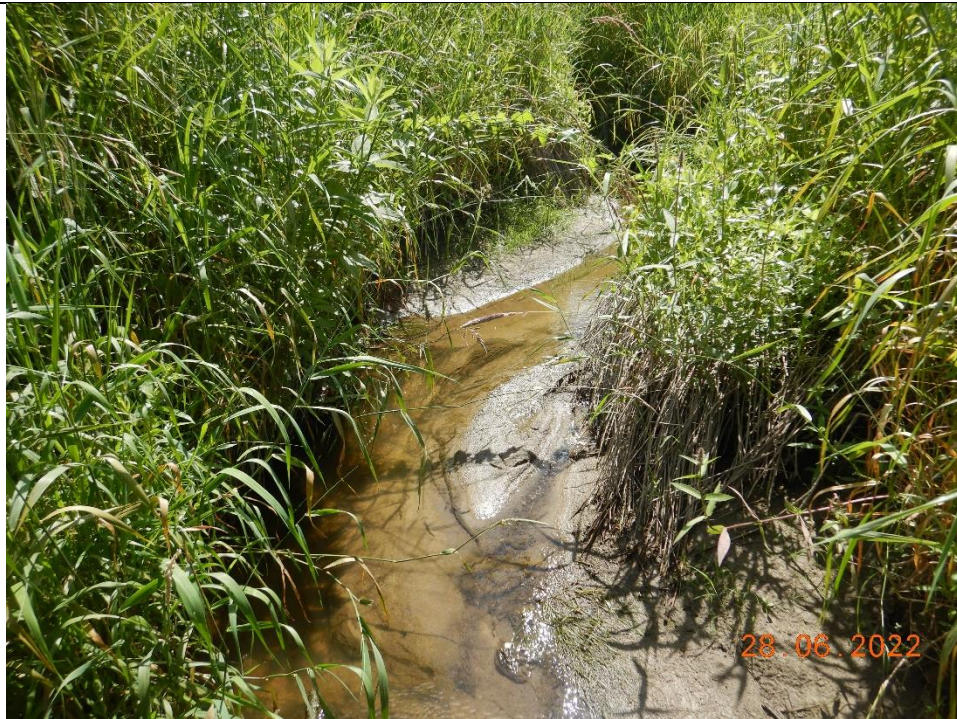
Photo 38
Ramsey Creek- Reach RC3, Ottawa, Ontario

Deposition was commonly observed throughout the reach. Channel bed substrate was composed of fine silt over compact clays.

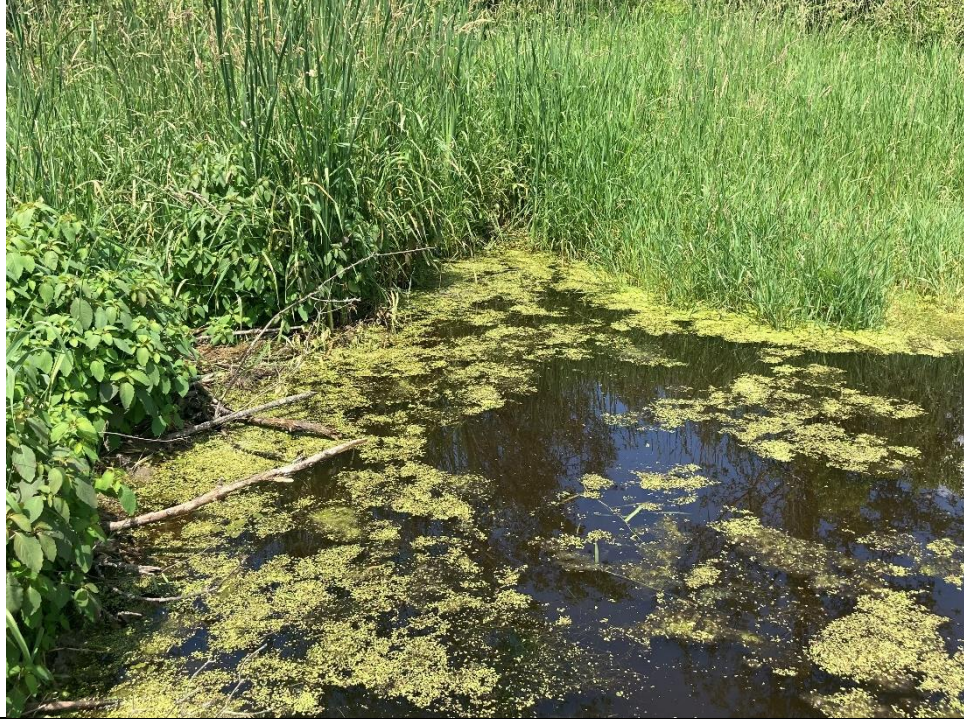
Photo 39
Ramsey Creek- Reach RC3, Ottawa, Ontario

A large, well established beaver dam was located halfway throughout the reach, causing a large area of backwater.

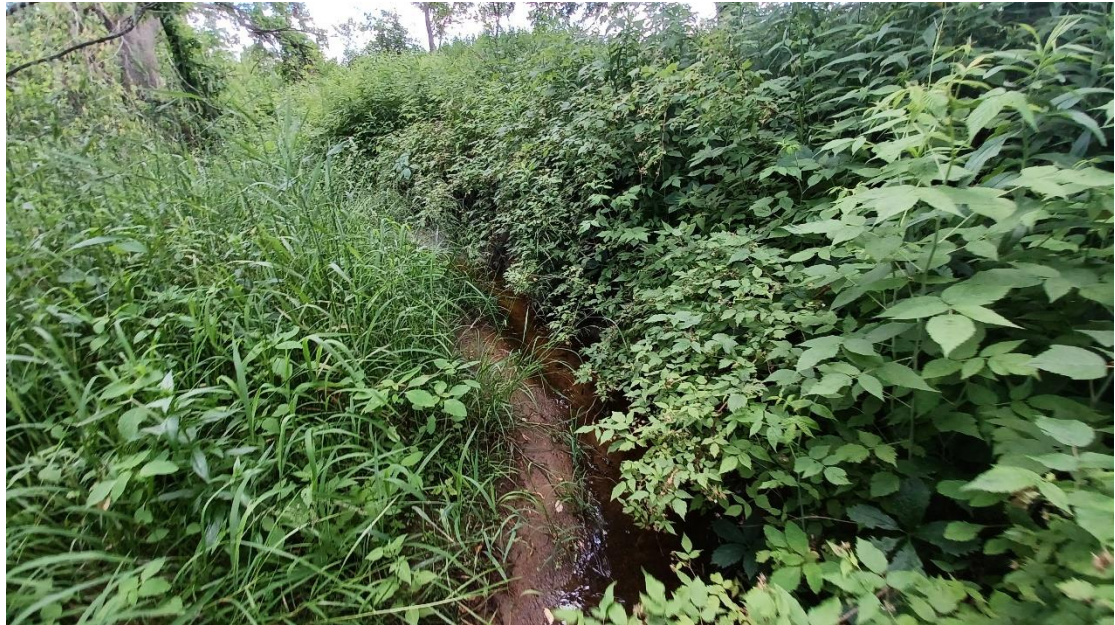
Photo 41

Ramsey Creek- Reach RC4, Ottawa, Ontario

The reach exhibits a straightened planform as it travels between two actively cultivated fields. The channel was dominated by runs with no riffle-pool features observed. The riparian edges were composed of grasses and trees in forested sections.

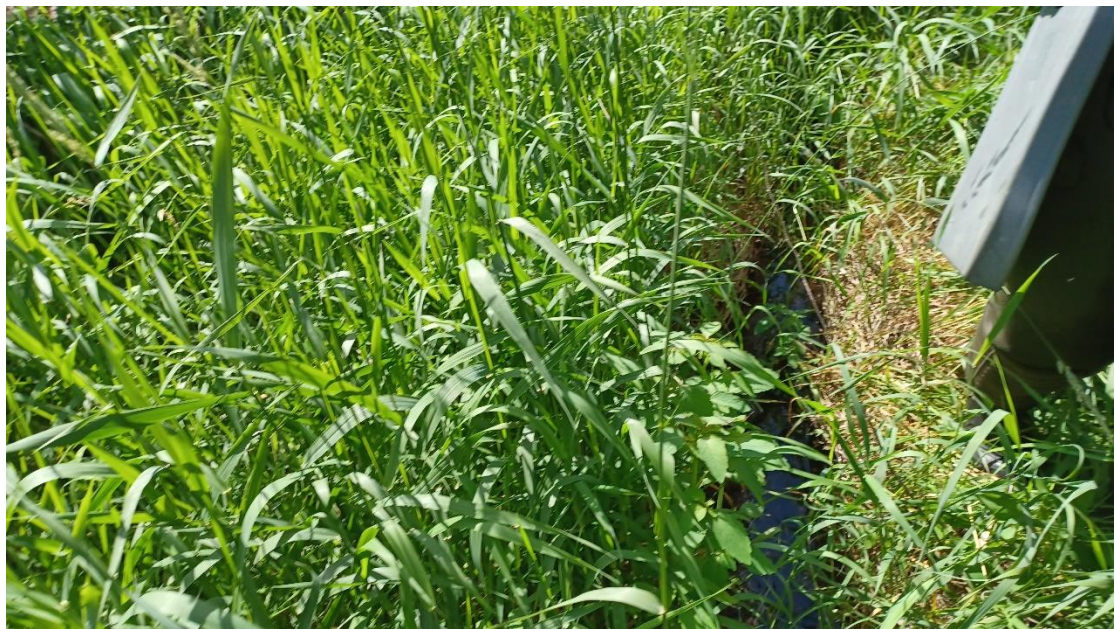
Photo 42

Ramsey Creek- Reach RC4, Ottawa, Ontario

Between sections of forest, the channel is narrow, and at times, poorly defined. Vegetation encroachment is extreme along most of the reach. Little signs of erosion were observed.

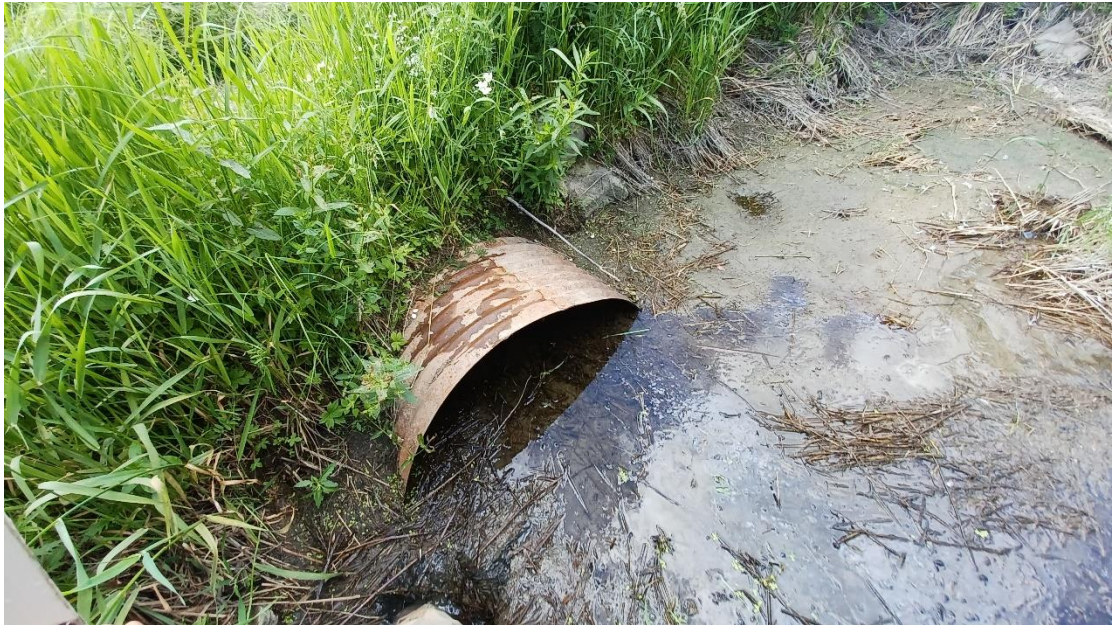
Photo 43
Ramsey Creek- Reach RC4, Ottawa, Ontario

A historic farm crossing was observed along the upstream extent of the reach. The buried culvert has caused backwatering.

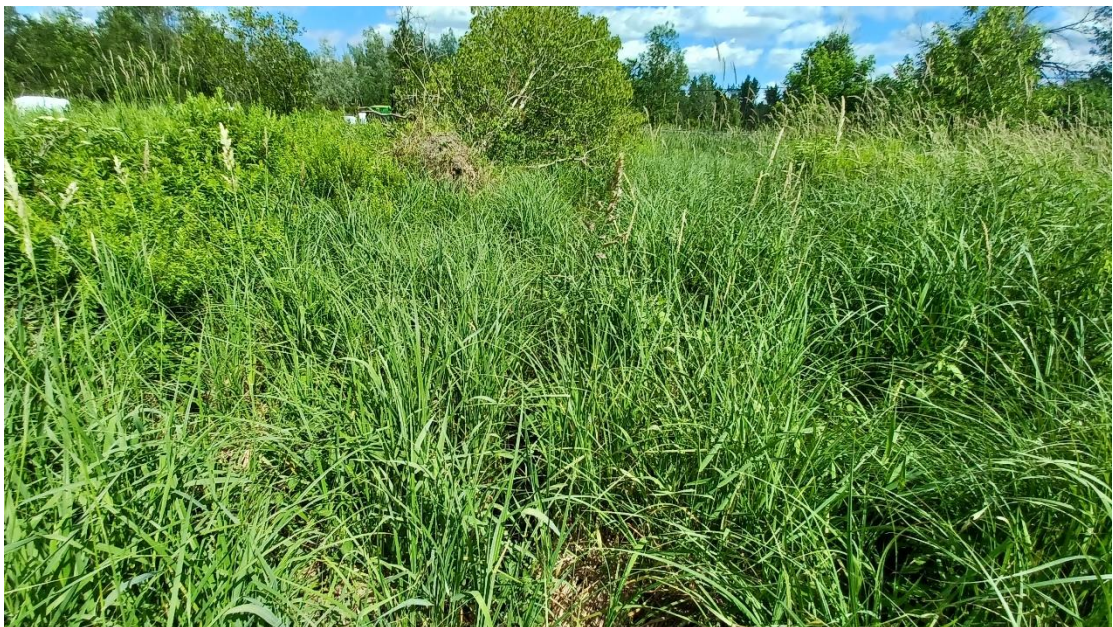
Photo 44
Ramsey Creek- Reach RC4, Ottawa, Ontario

Along the upstream extent of the reach, the channel loses definition and flows interstitially through grasses and cattails.
