Bear Brook and Ramsay Creek Watersheds Fluvial Geomorphological Study

Existing Conditions Summary Report Tewin Lands

December 12, 2024

GEO Morphix Project No. 21063

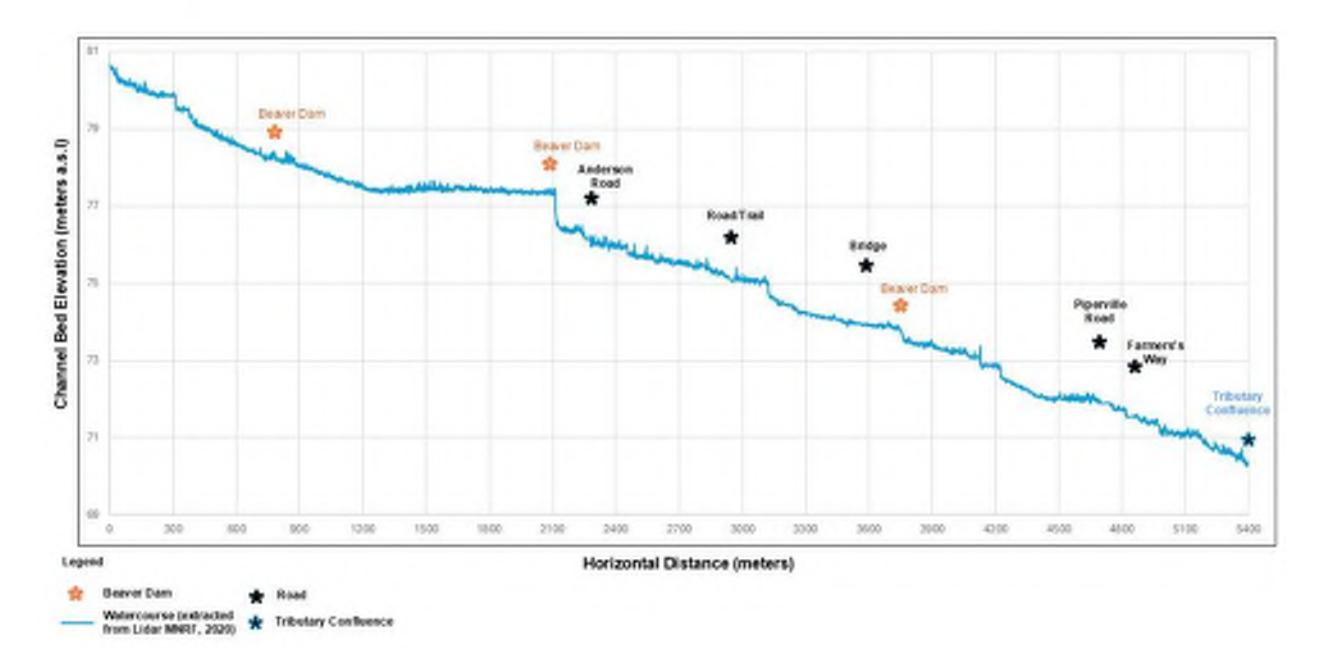
The length of Bear Brook was divided into Bear Brook North and Bear Brook South, which are presented below in **Figures 2** and **3**.

Overall, the longitudinal profiles along the main branch of Bear Brook exhibited the greatest change in slope around beaver dams, crossings, and tributary confluences. Generally, the areas with relatively lower gradients tended to precede beaver dams, most likely due to the deposition caused by backwatering and slower flows, as observed in the field assessments summarized in Section 3.

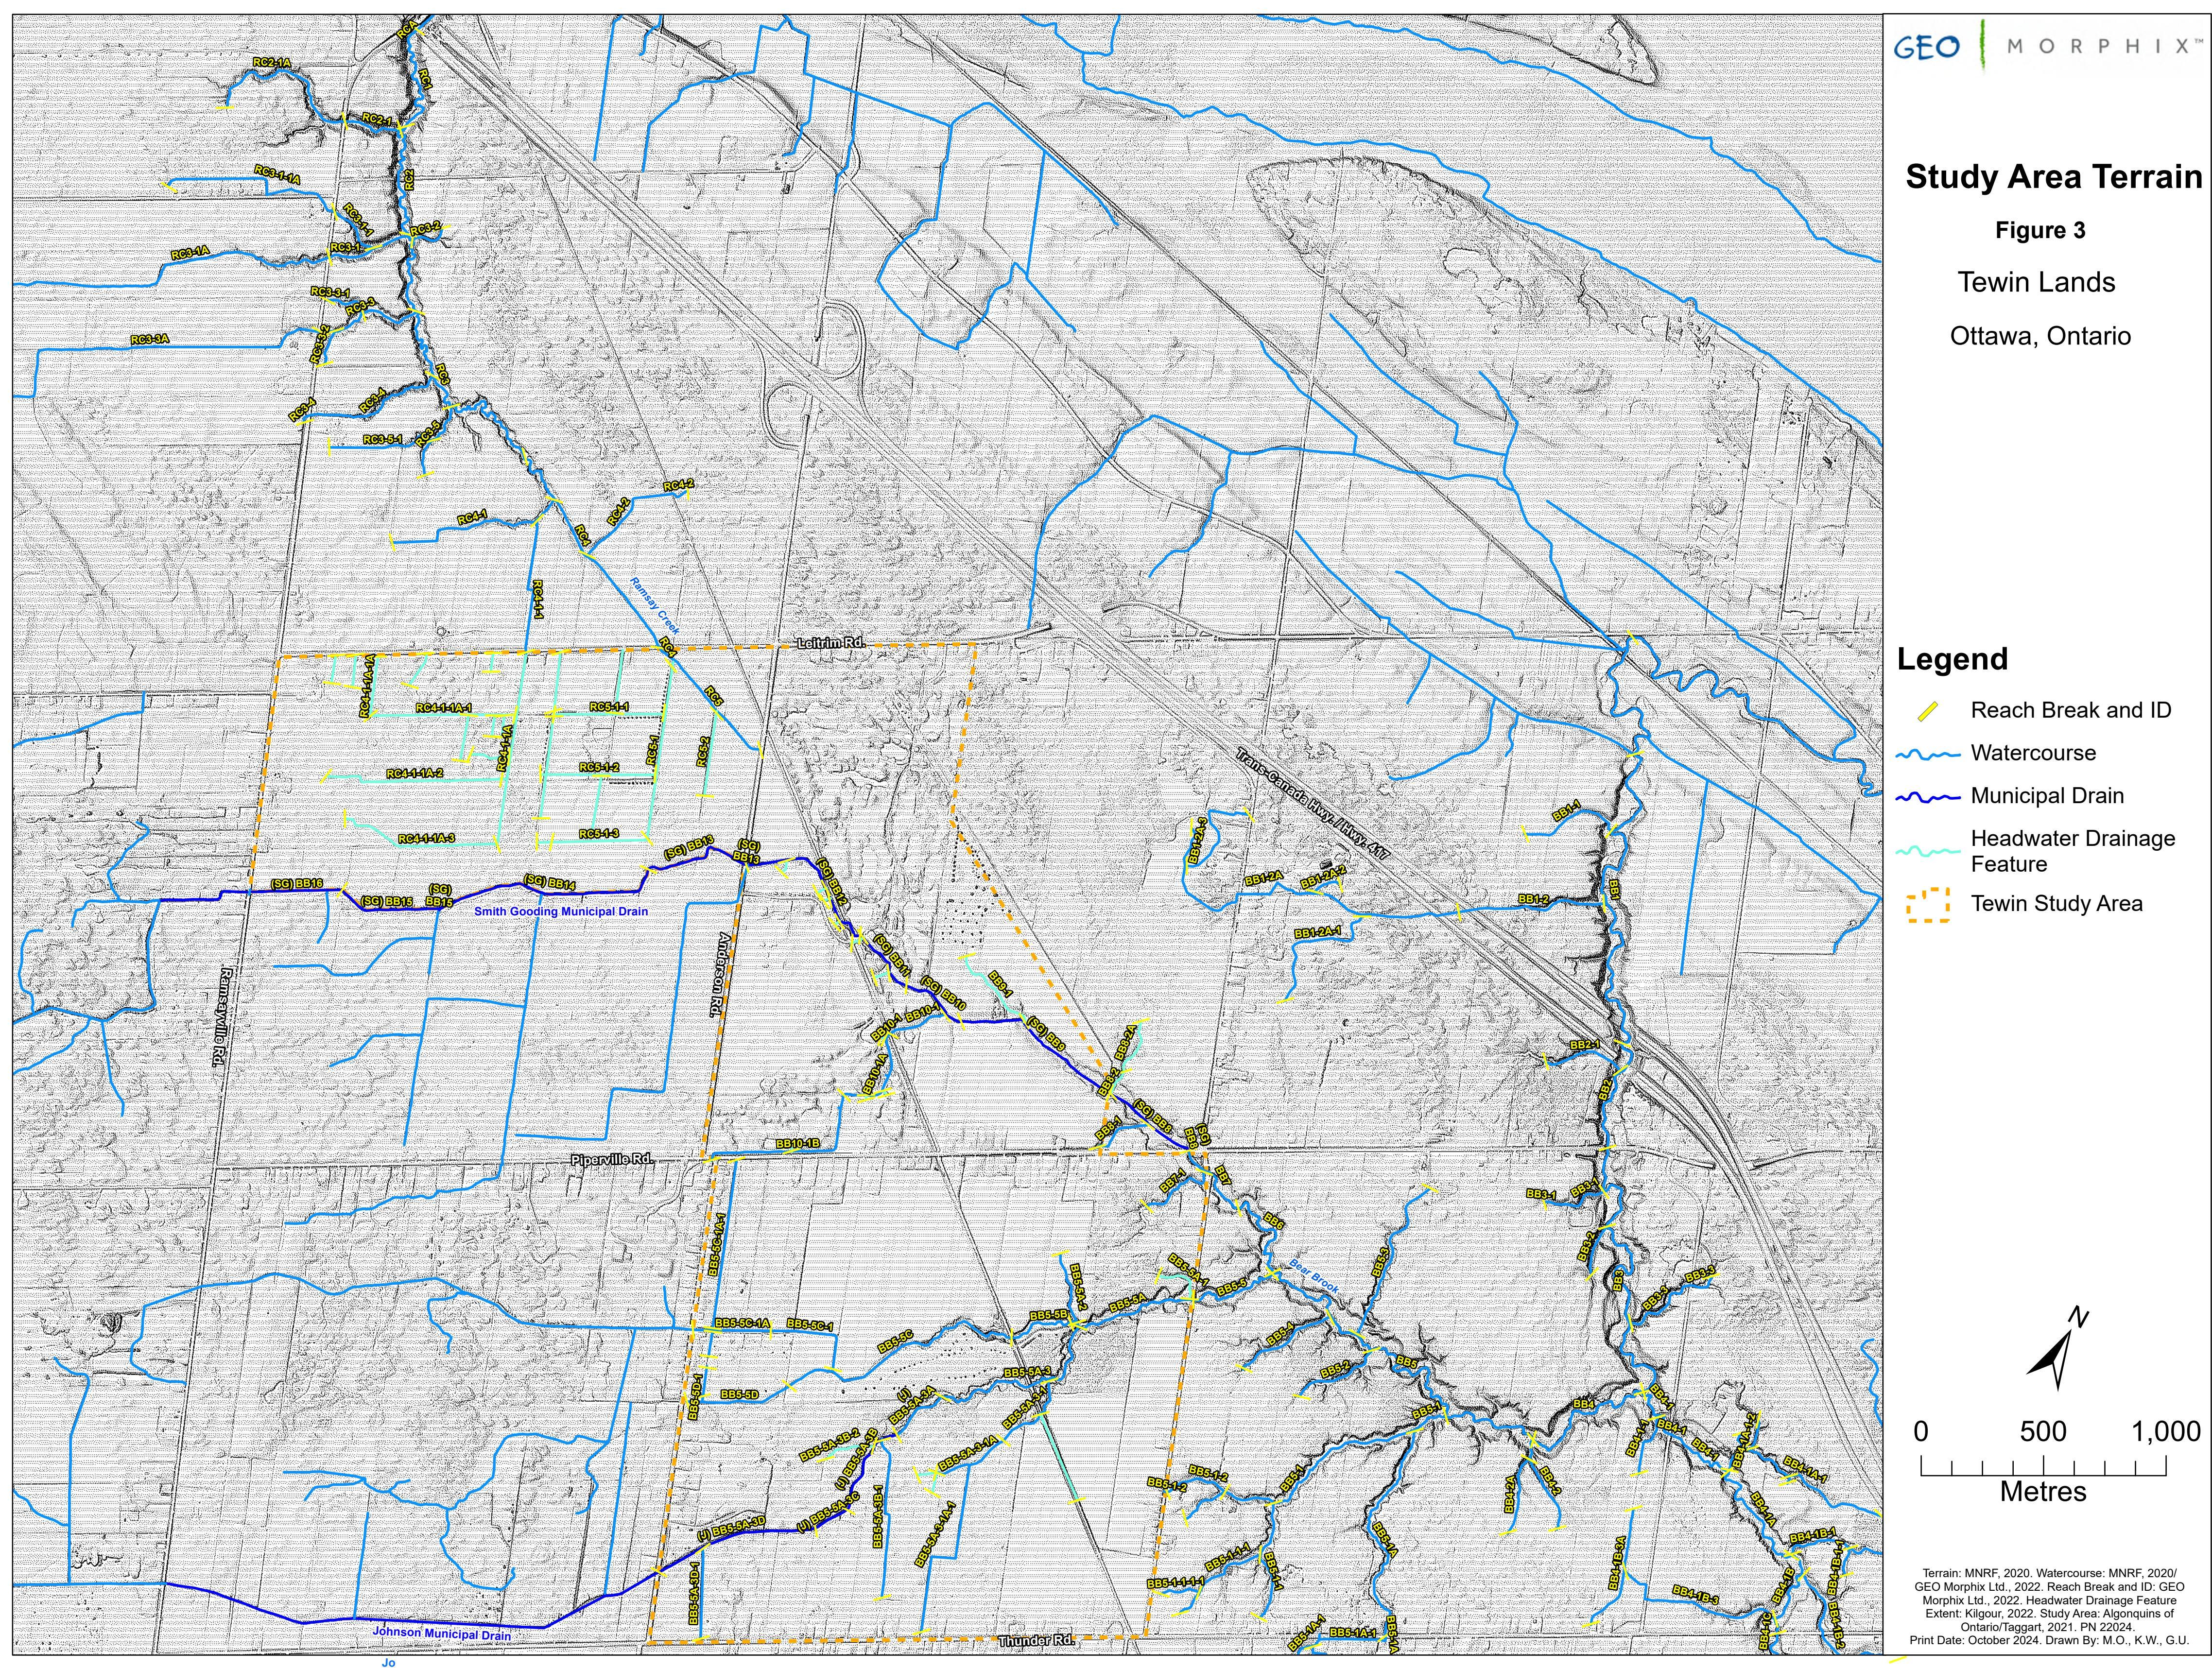
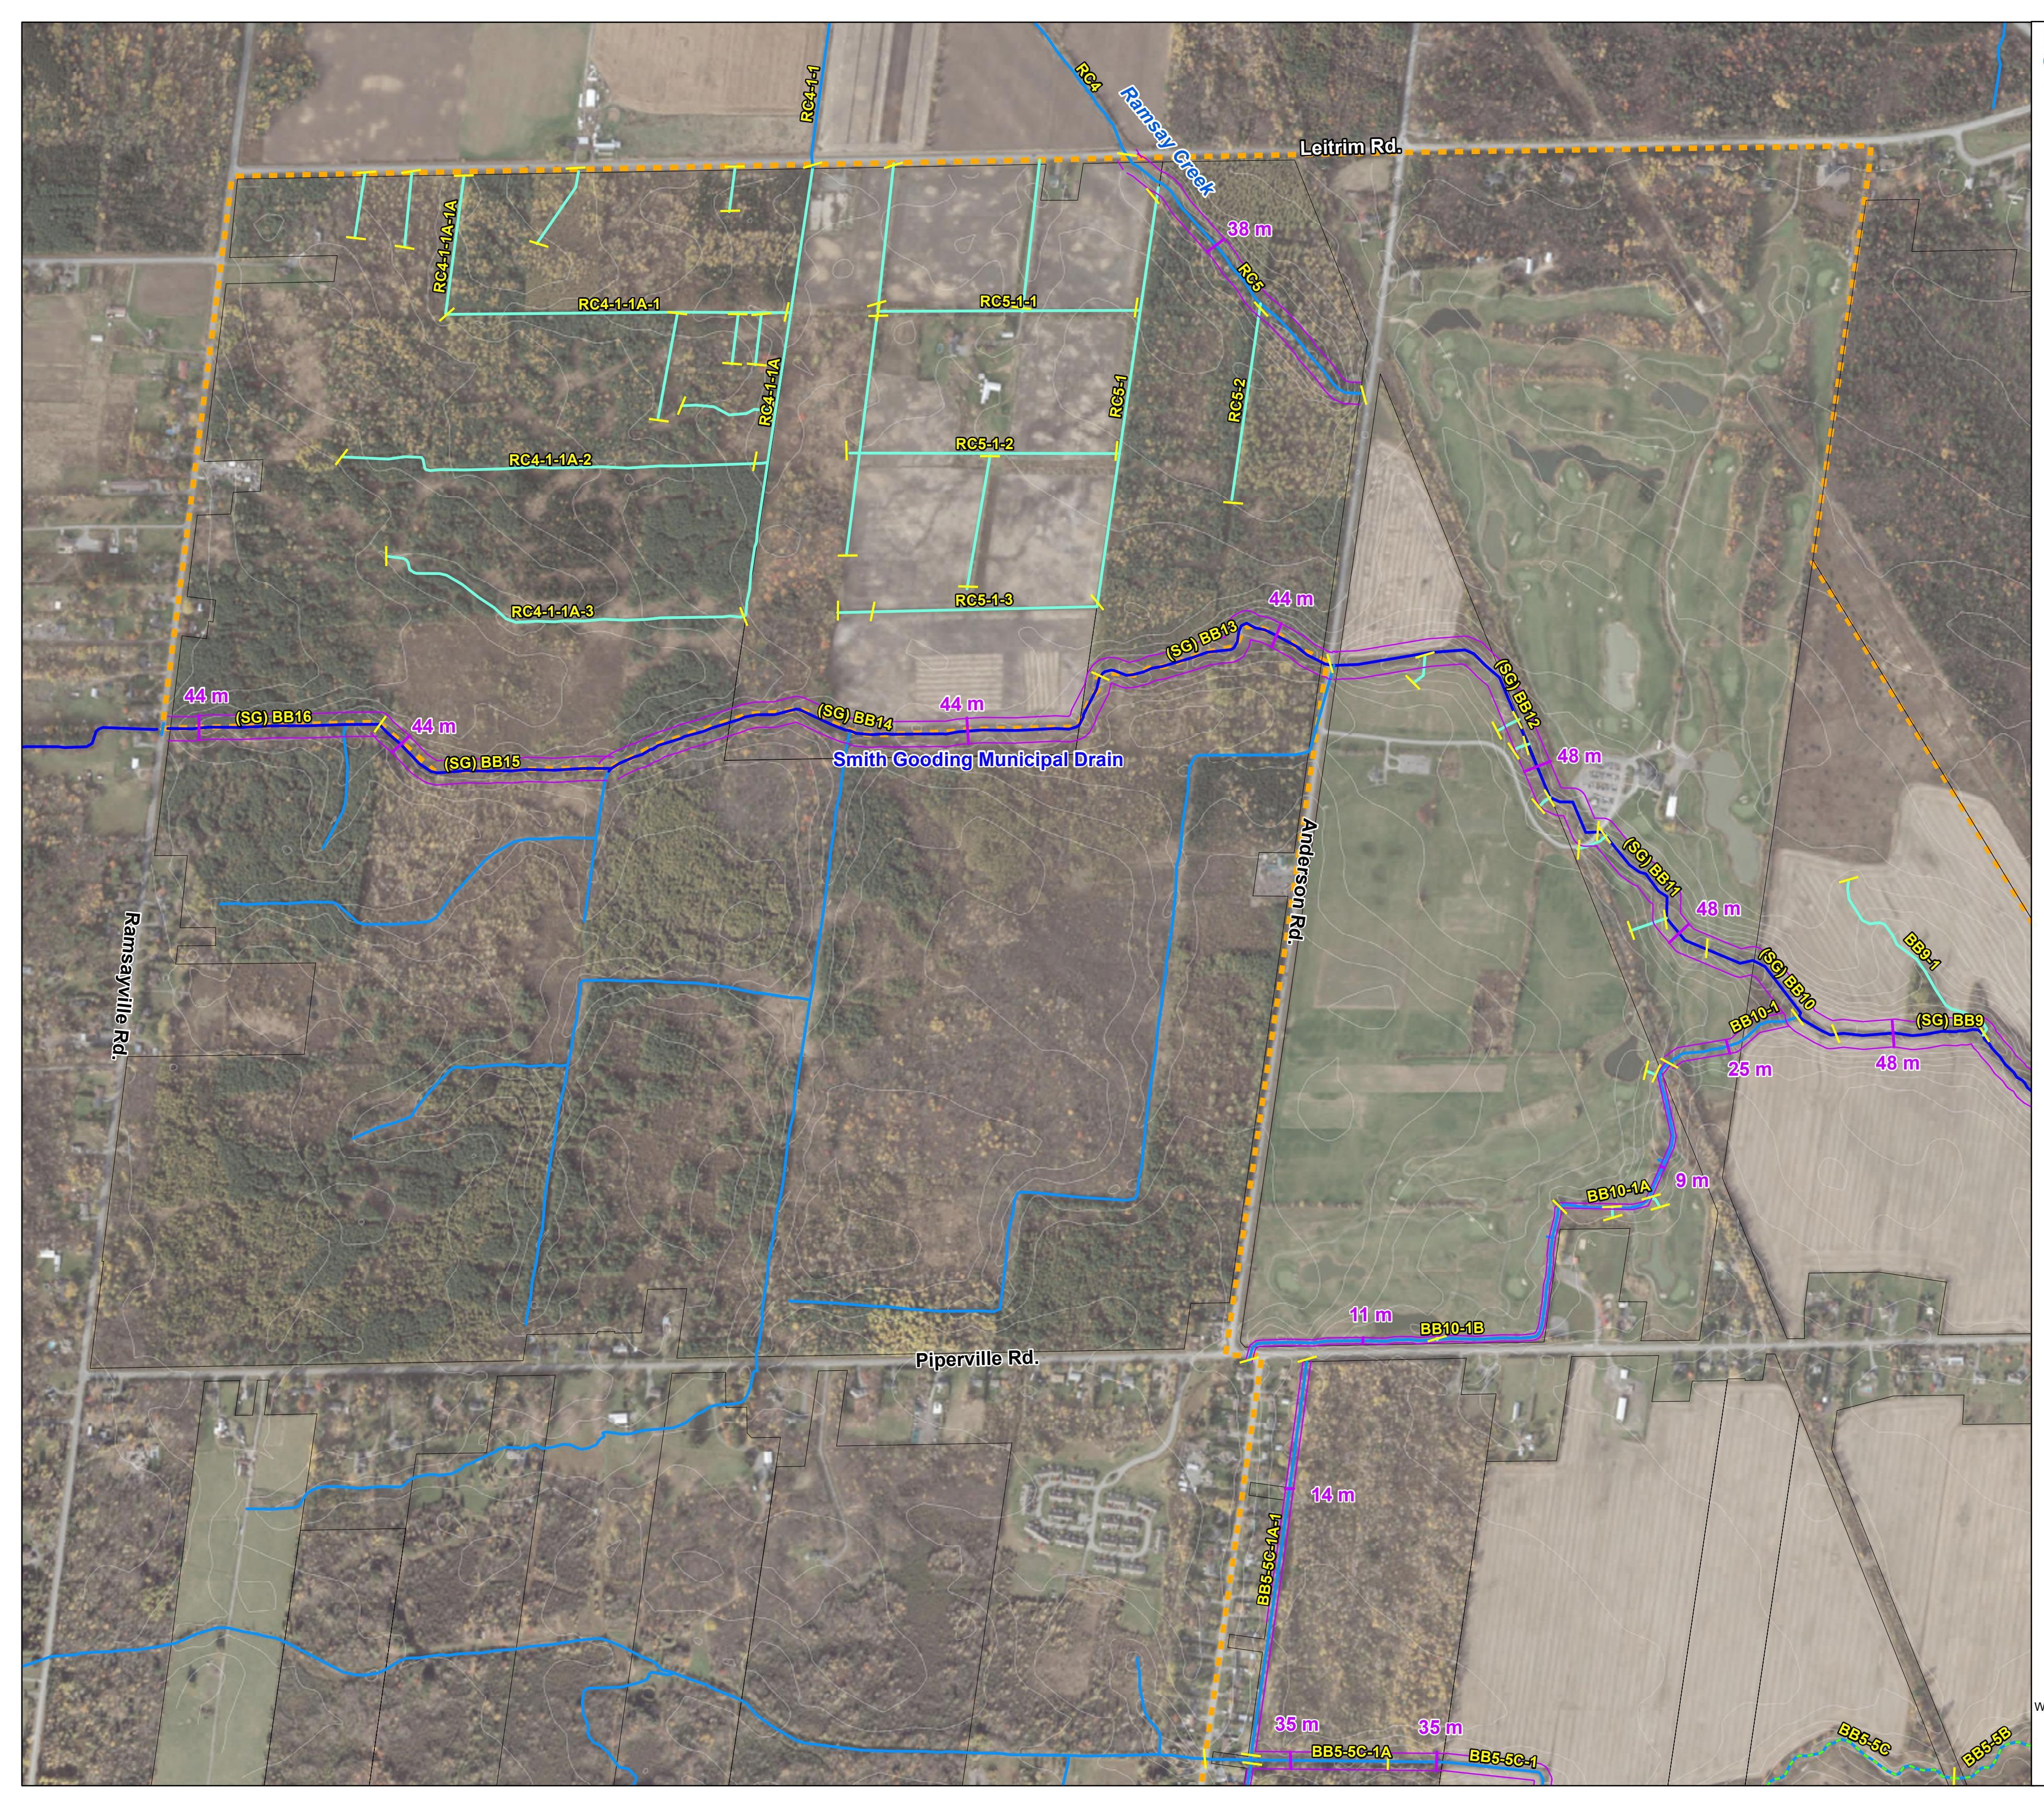
Figure 4a Tewin Lands Ottawa, Ontario

Preliminary Erosion Hazard Mapping

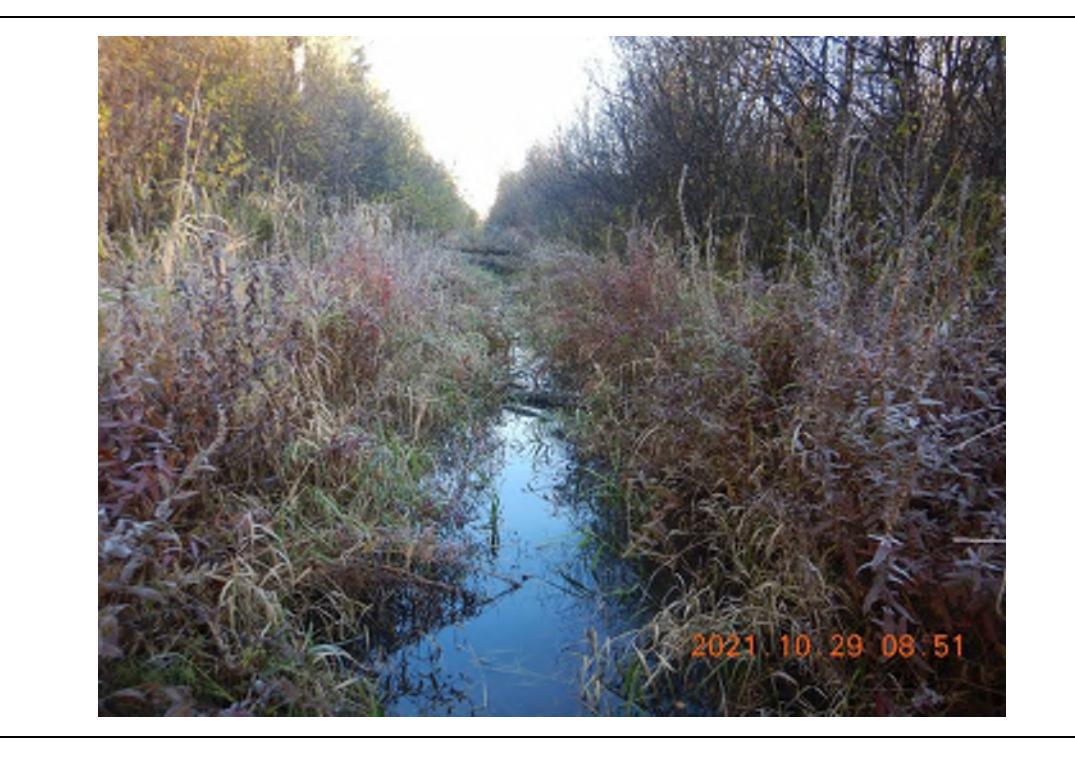
Photo: 21 Bear Brook: BB5-5A-3-1A

Riparian vegetation consisting of grasses and shrubs, low entrenchment identified.

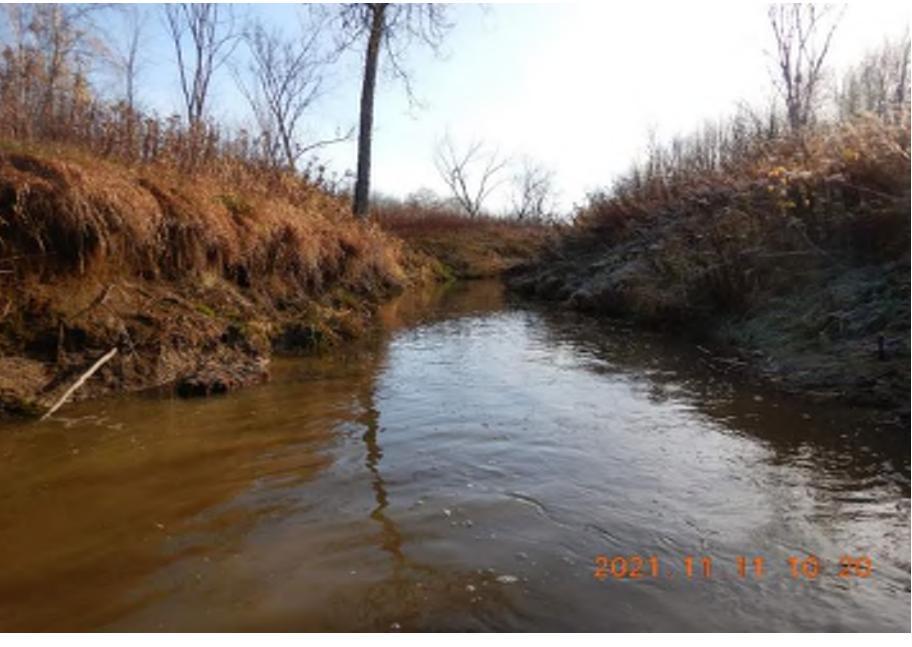
Cross Section 3 - Facing Upstream

Reach BB5 was a low gradient, meandering channel that passed through a partially confined valley. Riparian vegetation was characterized by grasses in the floodplain and on the valley slopes. There was minimal encrochment of vegetation to the channel and some reeds were found in th channel. Substrate consisted of clay to Sand in riffles and pools. Average bankfull width and depth were 5.97 m and 0.82 m, repsectively. Undercutting was minimal and was measured up to a maximum of 0.12 m.

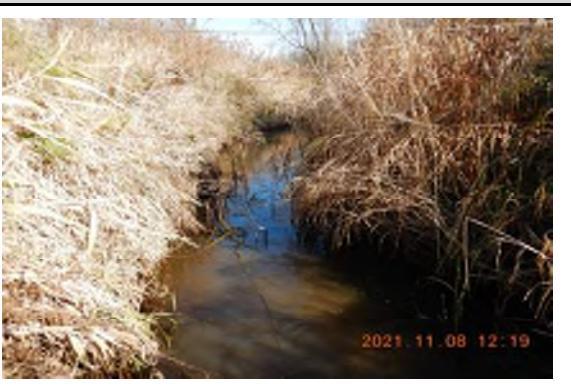
Photograph at cross section 2 (looking downstream)

Reach BB5-5 was a minimal gradient, meandering channel that passed through a partially confined valley. Riparian vegetation was characterized by grasses in the floodplain and on the valley slopes. There was minimal encrochment of vegetation to the channel and some reeds were found in th channel. Substrate consisted of clay to sand in riffles and pools. Average bankfull width and depth were 4.34m and 0.59 m, repsectively. Undercutting frequency was minimal and was measured up to a maximum of 0.45 m.

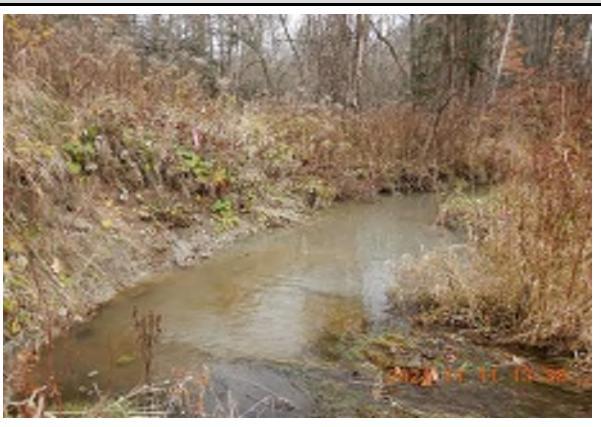
Photograph at cross section 2 (looking upstream)

Reach BB5-5A-3 was a moderate gradient, meandering channel that passed through a partially confined valley. Riparian vegetation was characterized by grasses in the floodplain and trees on the valley slopes. Substrate consisted of clay to cobbles in riffles and pools. Average bankfull width and depth were 6.31 m and 0.39 m, repsectively. Undercutting was fairly common and was measured up to a maximum of 0.93 m.

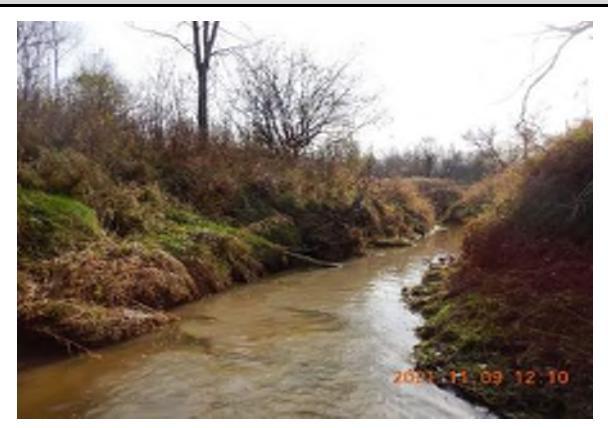
Photograph at cross section 6 (looking downstream)

Reach BB6 was a minimal gradient, meandering channel that passed through a partially confined valley. Riparian vegetation was characterized by grasses in the floodplain and on the valley slopes. There was minimal encrochment of vegetation to the channel and some reeds were found in the channel. Substrate consisted of Clay to Sand in riffles and pools. Average bankfull width and depth were 4.73 m and 0.94 m, repsectively. Undercutting frequency was minimal and was measured up to a maximum of 0.45 m.

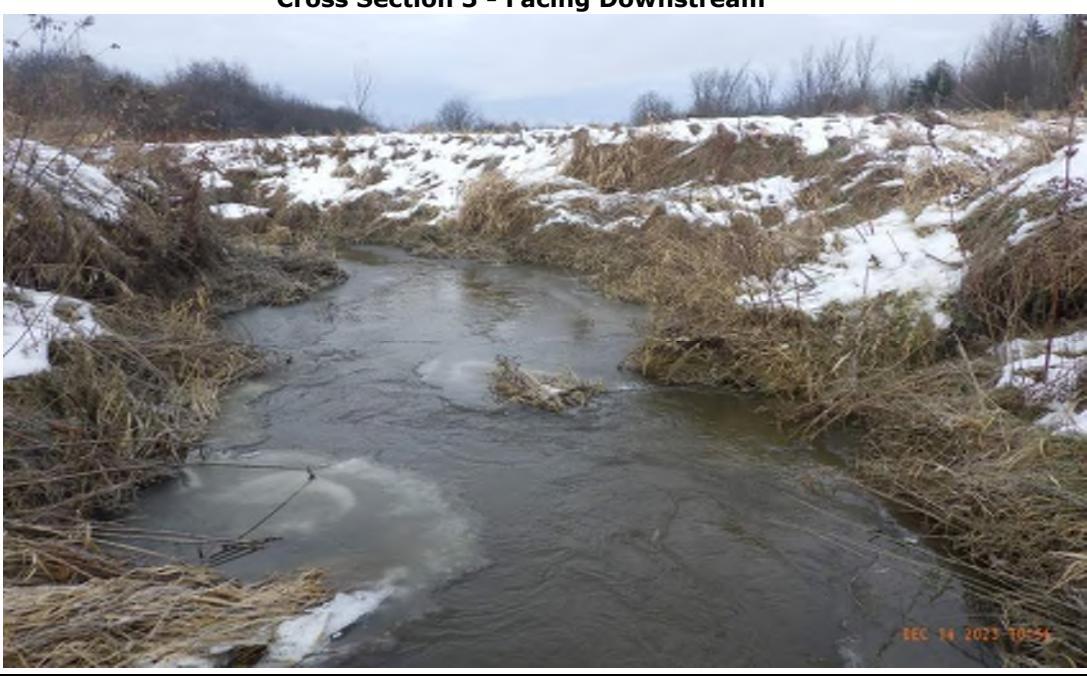
Cross Section 3 - Facing Downstream
Appendix G TRCA Meander Belt Width Values

Reach RCB meanders through active agriculture with a grassy buffer between the channel and the cultivated lands. There was no riffle formations, and was mostly composed of runs and pools. The riparian vegetation encroaches the channel and instream rooted emergent vegetation was well established. Channel slumps, fracture lines and undercutting was observed throughout the reach. The channel bed was composed of soft silt and sand over a compact clay-till subpavement. Some sections of the reach exhibited exposed compact clay-till on the bed. During the time of the assessment, the channel was iced over, however the average bankfull width and depth was 5.85 m and 0.80 m respectivley, and wetted with and depth at 2.73 m and 0.31 m , respectivly.

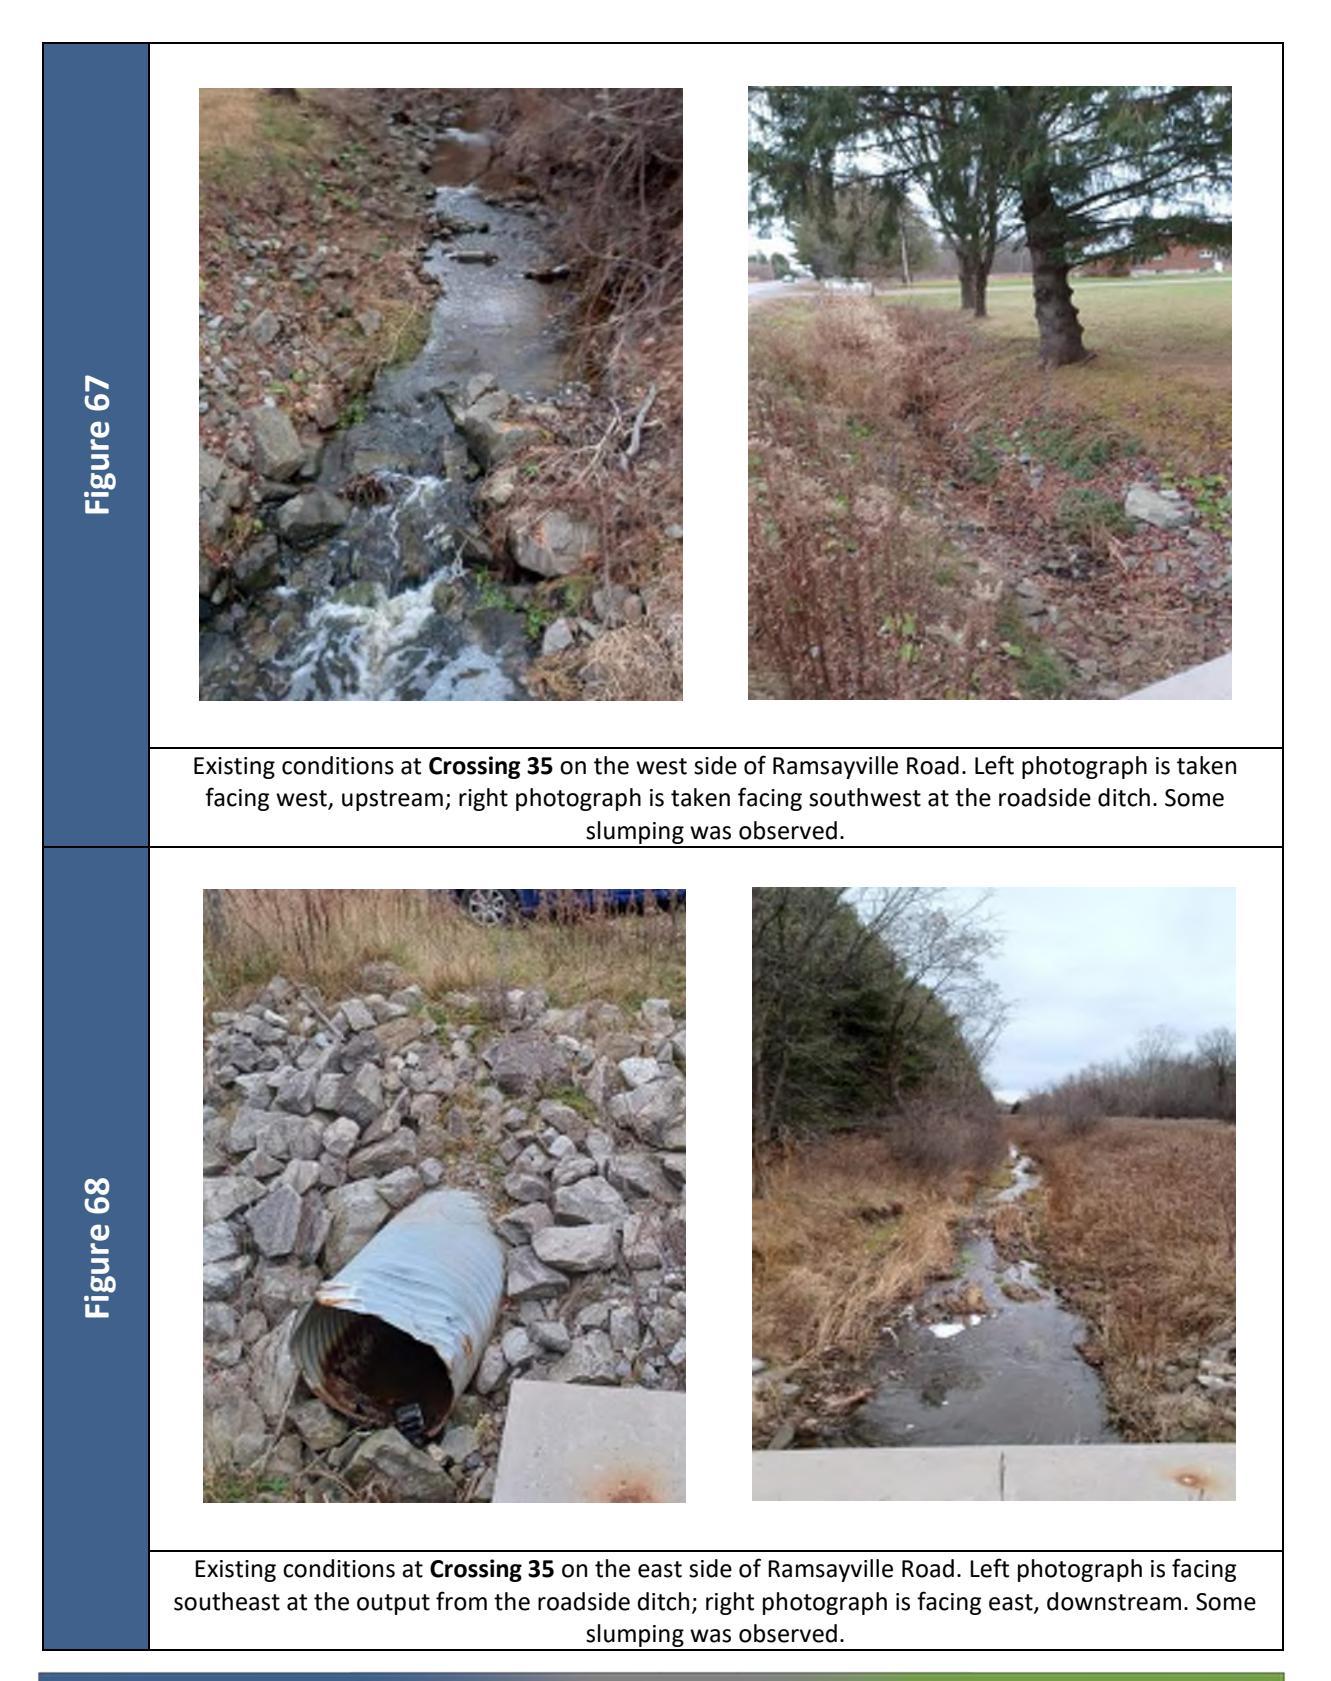
southwest along the roadside ditch; right photograph is taken facing southeast towards downstream.
